RP 401

Recommended Practices for Onshore Wind Turbine Foundation Maintenance

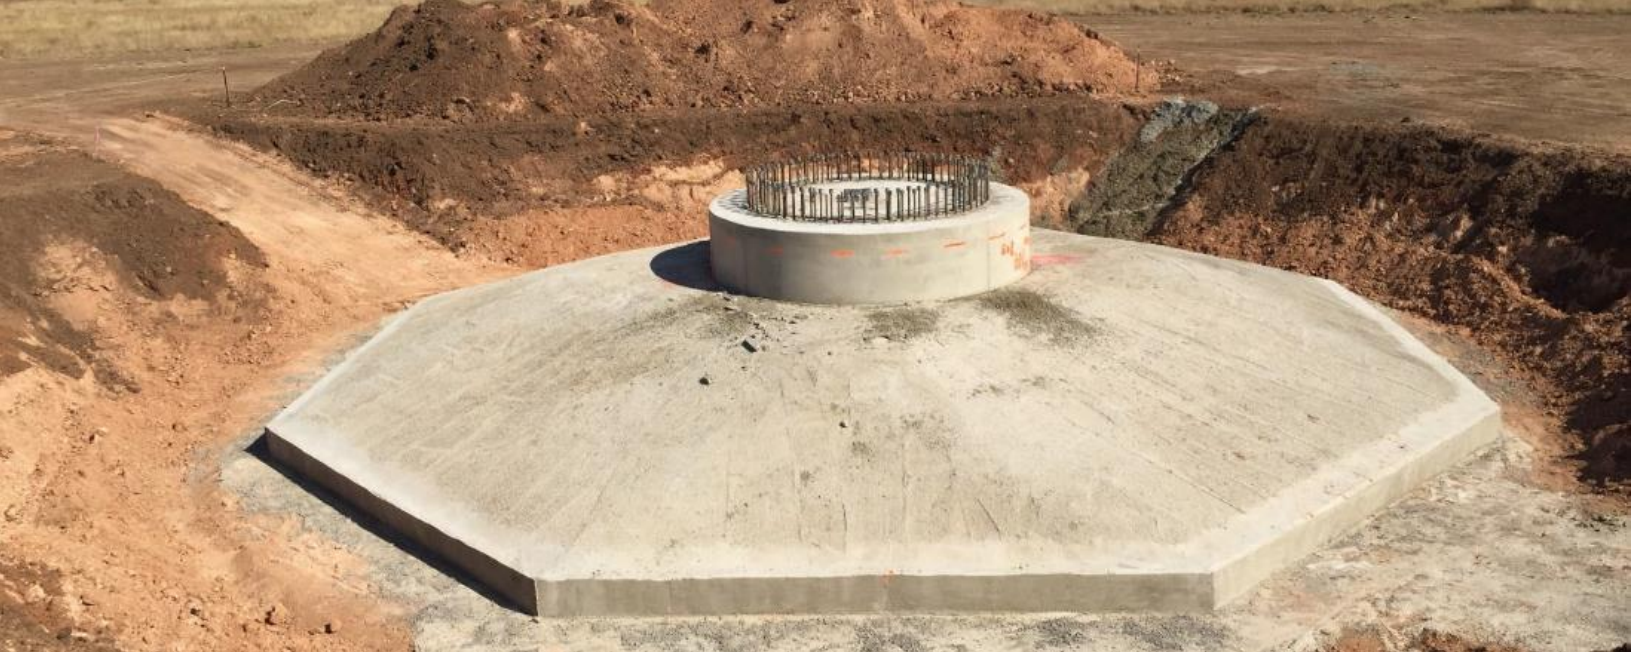
Figure 2. Typical gravity-based spread footing foundation in construction state prior to being covered with backfill.

The most widely used foundation type is the gravity-based spread footing foundation which relies on the soil bearing resistance, the weight of the foundation, soil backfill and wind turbine weight for stability. Figure 2 shows a typical gravity-based spread footing foundation prior to placement of backfill. The spread footing may be constructed in combination with soil corrections such as engineered fill, stone columns or dynamically compacted soils.

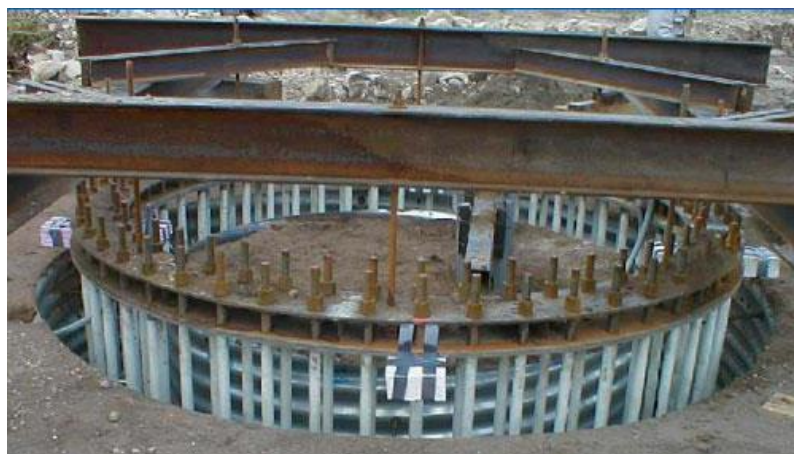
Figure 3. Tensionless tube foundation anchor cage ready for pour in left photo, and three-dimensional image illustrating the design elements of the tensionless tube foundation in the right photo.

The second most widely used foundation type is the Patrick and Henderson (P&H) style monopole, or tensionless tube foundation. The tensionless tube foundation is a deep foundation which relies on its embedment depth as well as lateral and friction resistance of the soil for stability. A post-tensioned concrete cylinder integral with connection to the tower provides the necessary structural strength to accomplish this. There are several variants of this style of foundation which incorporate a concrete collar with or without post-tensioned rock or soil anchors around the foundation. A typical design of this foundation type is shown in Figure 3.

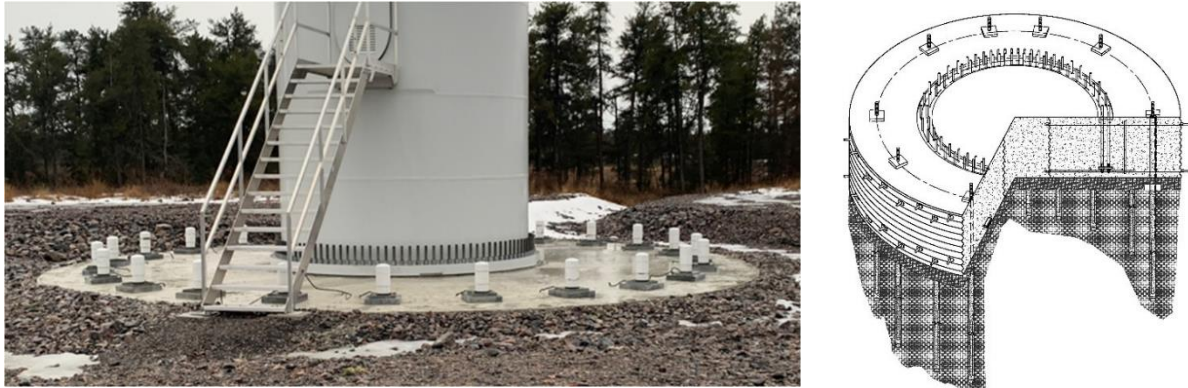
Figure 4. Rock anchor foundation in service in left photo, and three-dimensional image illustrating the design elements of the rock anchor foundation in the right photo.

The rock anchor foundation is a style of foundation commonly used in strong, massive rock conditions. This style of foundation relies on the embedment of rock anchors in the rock mass and the rock bearing

resistance for the anchor cap to provide stability. A typical design of this foundation type is shown in Figure 4.

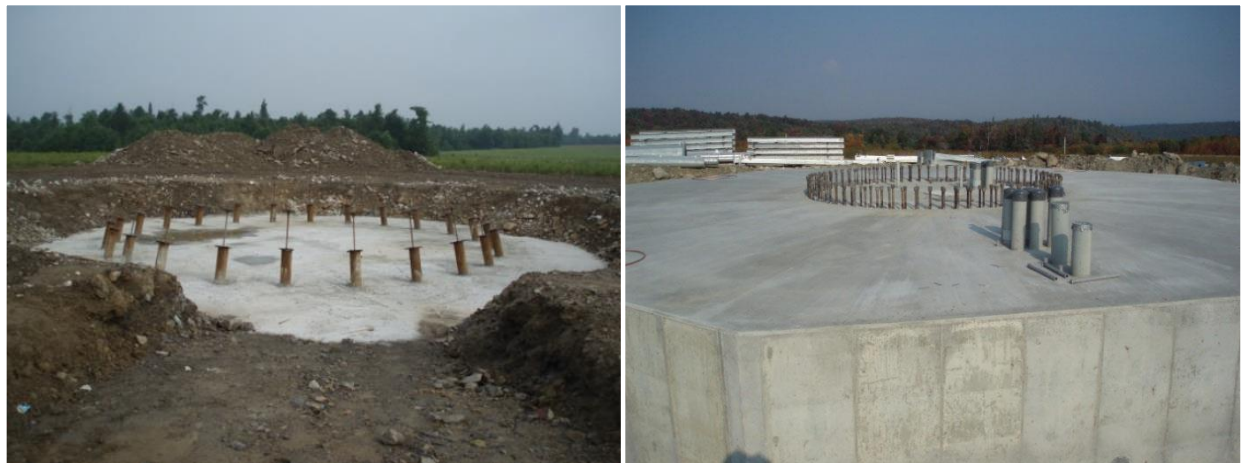
Figure 5. Pile supported cap foundation in construction in left photo and completed foundation in right photo.

The pile supported cap foundation can be a rock or soil anchor foundation. This style of foundation is constructed where poor soil conditions are present to depths greater than 40 feet. The foundation relies on the weight of the foundation and the tension and compressive strength of the piles to carry loads to deeper, stronger soil or rock layers for stability. The pile supported cap foundation can be utilized in rock with percussion drilled piles using post-tensioned all thread anchor bolts or utilized in soil with drilled soil anchors post-tensioned. Figure 5 shows the piles installed prior to concrete placement and the completed pile cap after.

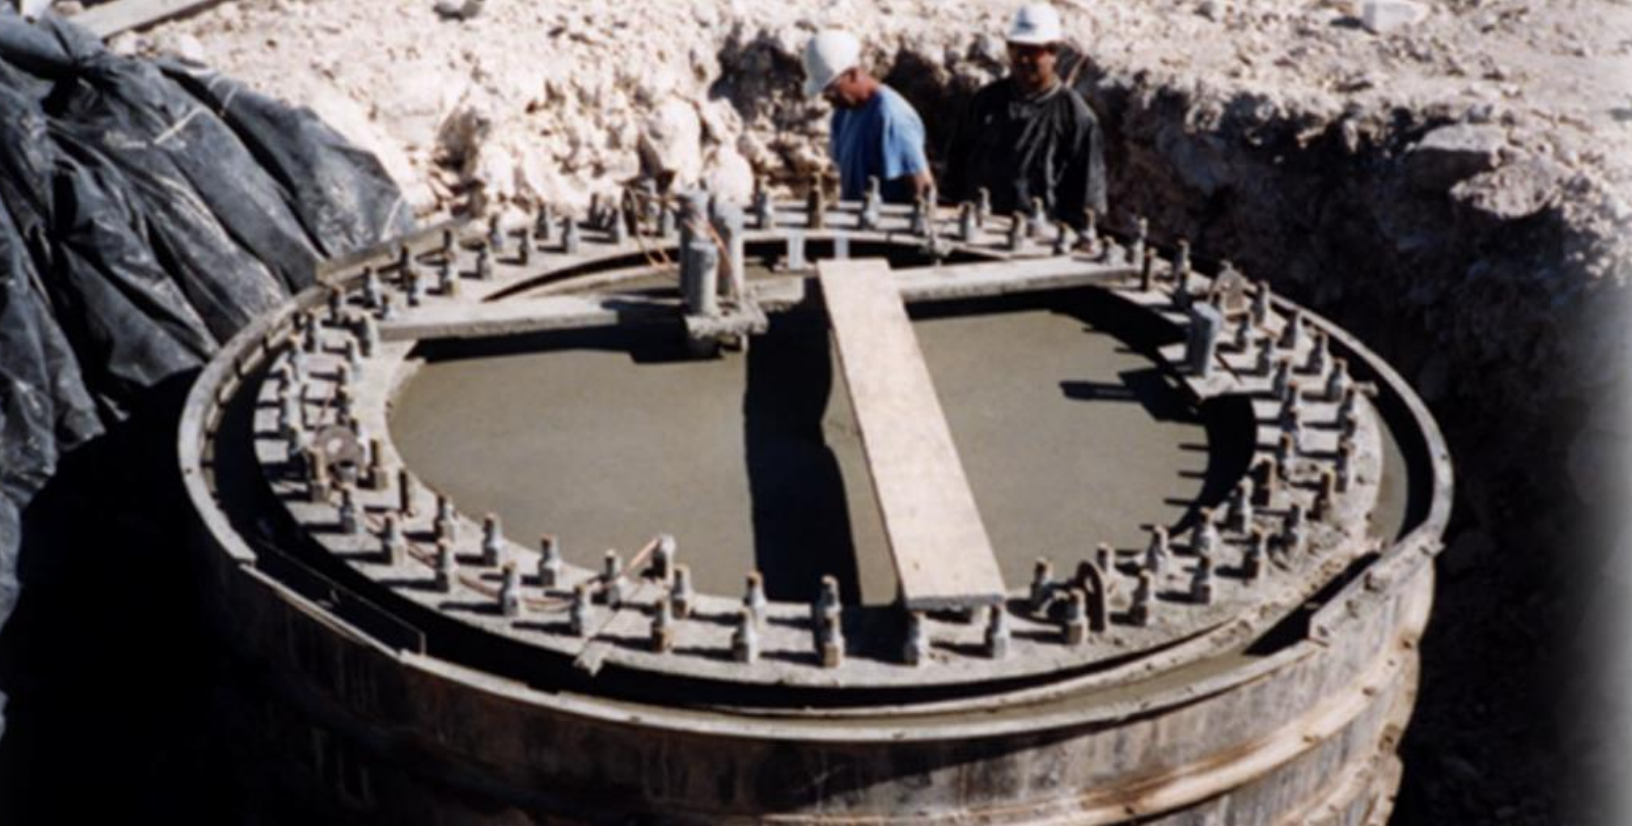
Figure 6. Rock socket foundation in construction prior to backfill.

The rock socket foundation is the least common foundation type and is used in moderate strength, and massive rock conditions. The rock socket is like the tensionless tube foundation in that it also relies on embedment depth and the lateral and friction resistance of the surrounding material for stability which in this case is rock. Figure 6 shows a rock socket foundation in construction progress after placement of concrete.

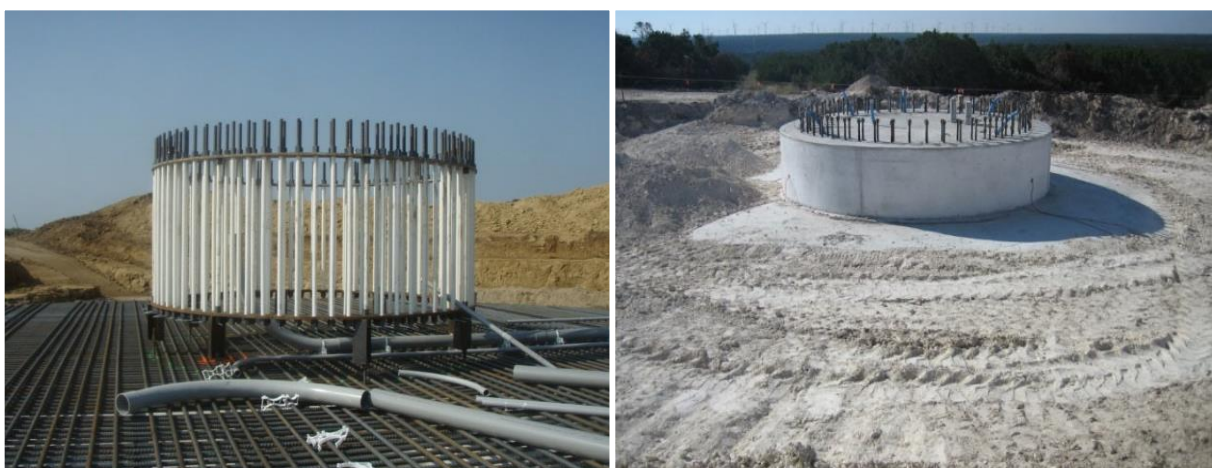
Figure 7. Anchor bolt/embedment plate assembly prior to concrete placement shown in left photo and fully constructed foundation in the right photo.

An anchor bolt/embedment plate assembly is the most common type of connection made between the tower and the foundation. The anchor bolts are tensioned after concrete curing primarily to minimize fatigue of the anchor bolts. However, in the case of a tensionless tube foundation, the anchor bolts also provide pre-tensioned reinforced concrete strength. Figure 7 shows an anchor bolt embedment plate assembly during and after construction.

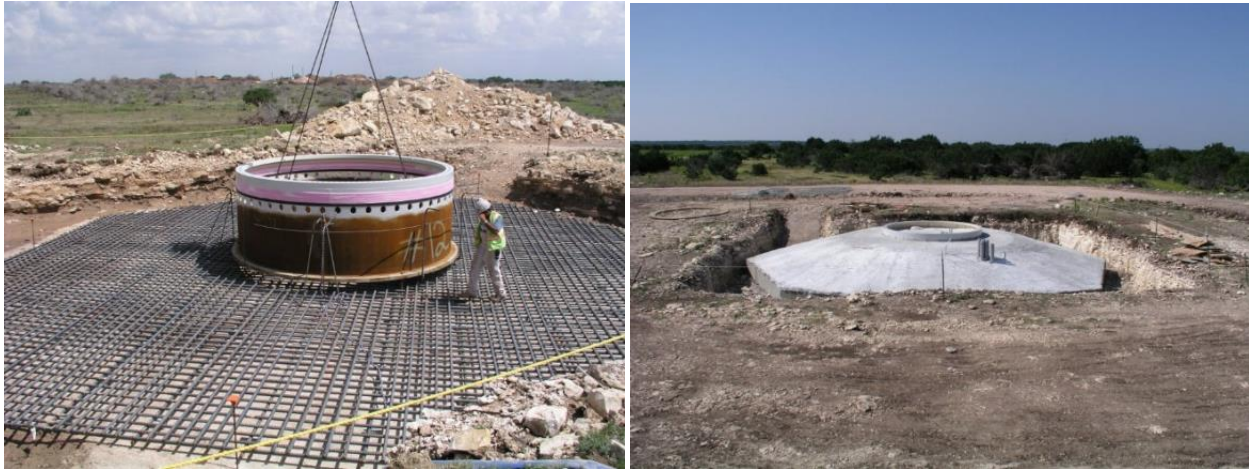
Figure 8. FMP connection prior to construction of foundation in left photo and fully constructed FMP style foundation prior to backfill shown in right photo.

The foundation mounting part/piece (FMP) is a method for connecting the tower to the foundation and was primarily used around the year 2010, however some FMP type towers were constructed later. This method of connection originated from Europe and was tried in North America at several facilities. Ultimately, the anchor bolt/embedment plate assembly became the preferred option. Figure 8 shows an FMP during and after construction.

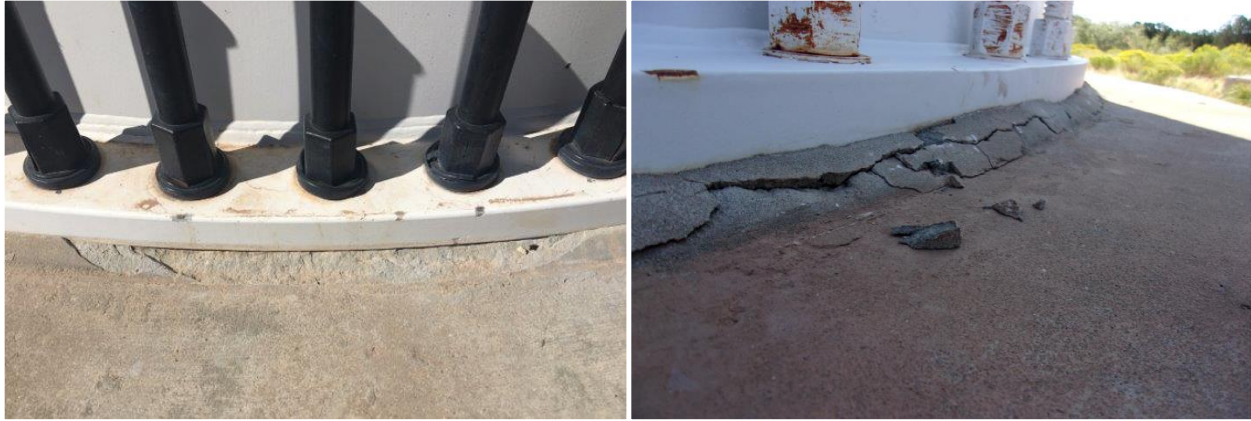
Figure 9. Early-stage spalling in left photo and late-stage spalling with significant cracking in right photo.

Grout spalling is the loss of material from the grout bed in chunks. When grout spalls, it is a sign of weak and failing grout or turbine base flange impact when separated from the grout by flange movement. Spalling is most often seen with cementitious grout, though it is possible for epoxy grout to fail similarly. Examples of grout spalling in cementitious grout are shown in Figure 9.

When grout spalls, the load transfer from the tower flange to the pedestal may be disrupted. The loss of a continuous and smooth transfer of load from the tower flange to the pedestal may result in increased stress to the remaining grout and eventually to the concrete pedestal. If enough grout has failed, the originally constructed gap that the grout fills may be reduced enough to result in a loss of tension in the anchor bolts.

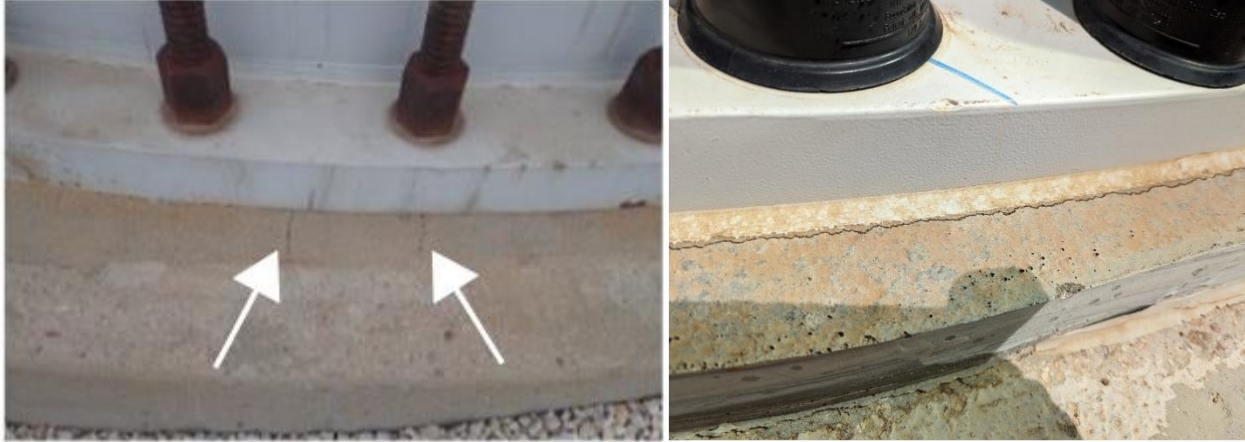
Figure 10. Radial cracking in cementitious grout in left photo and circumferential cracking in epoxy grout shown in right photo.

Grout cracks are continuous separation of the material observed in the surface of the grout. When grout cracks, it may be a sign of weak and failing grout. Cracking is most often seen with cementitious grout, though it is possible for epoxy grout to crack as well. Figure 10 shows examples of cracking in both common grout materials. The small vertical cracks in the cementitious grout on the left are very common. Cracks in epoxy grout are much less common.

The most common grout cracks are of radial orientation and found in cementitious grout. These cracks are typically shrinkage cracks that occur during the curing of the material and likely do not affect the load transfer from the tower flange to the pedestal if the material is largely intact underneath the flange. Circumferential cracking is less common and may be an indication of a structural problem and should be further investigated. Cracking allows ingress of water and the potential for freeze-thaw cracking and eventual possible spalling. If enough grout has failed, the originally constructed gap that the grout fills may be reduced resulting in a loss of tension in the anchor bolts.

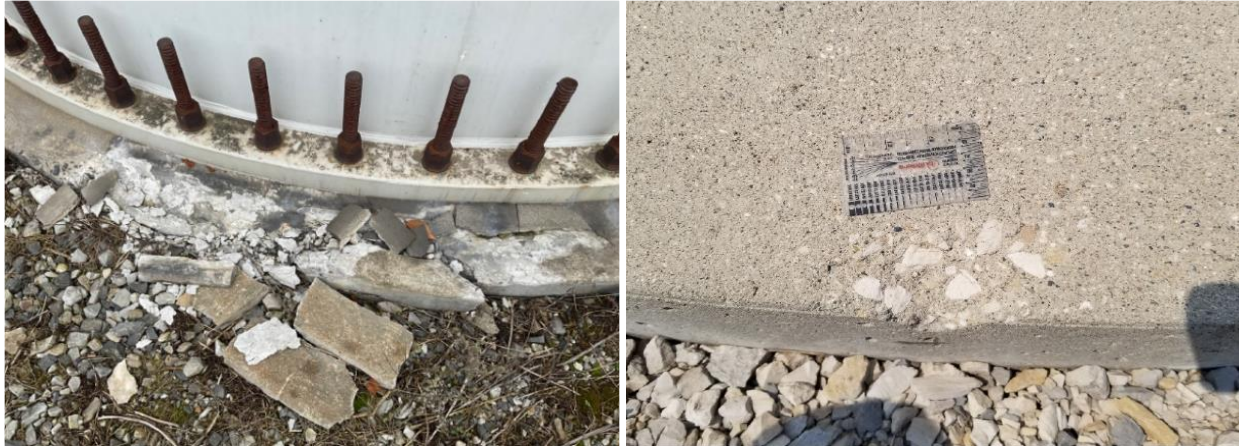
Figure 11. Structurally significant pedestal spalling in left photo and minor debris/impact pedestal spalling in right photo.

Spalling of the pedestal concrete is the loss of material from the pedestal in chunks. There are two categories of pedestal spalling, structurally significant and superficial. When concrete spalls and cracks, it may be a sign of weak and failing material. Examples of both categories of pedestal spalling are shown in Figure 11.

When pedestal concrete spalls, there may be no immediate impact on the distribution of loads and stresses if the material loss is small and away from the tower base flange. However, large spalls could expose reinforcement, reduce concrete cover and increase the risk deterioration of the rebar through corrosion. Pedestal spalling could be the result of weak concrete, corrosion of reinforcement, impact from debris, or exposure to fire or other environmental factors. Significant pedestal spalling could also be due to alkali-silica reactivity (ASR) of the concrete aggregate, which is less common.

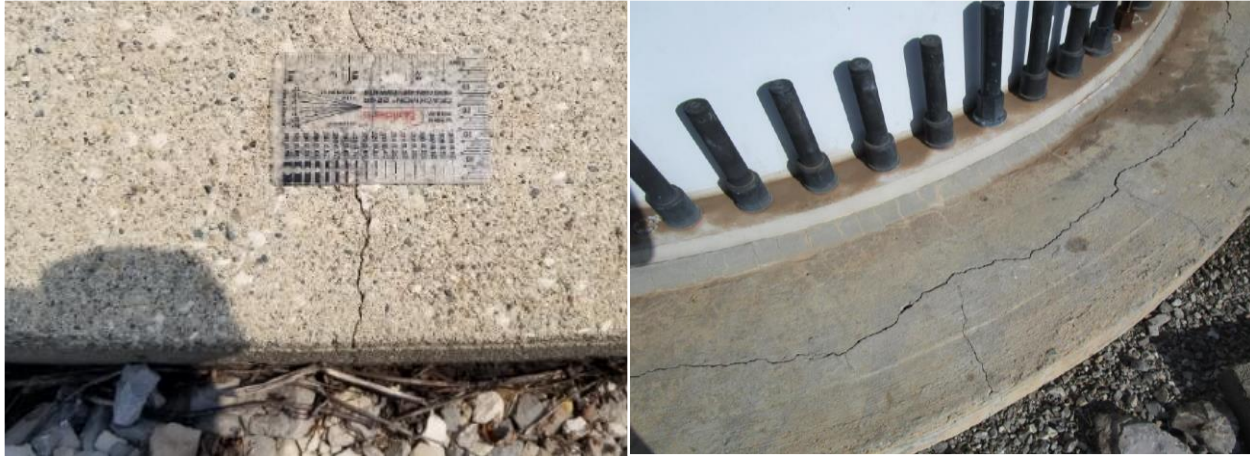
Figure 12. Pedestal radial shrinkage crack in left photo and more significant circumferential cracking in the right photo.

Pedestal cracks above the soil backfill are observable continuous separations in the pedestal concrete. Radial cracking in the pedestal as shown in Figure 12 on the left is quite common. It is understood this cracking happens during the curing stage and is known as shrinkage cracking. A larger and more concerning crack is shown in the photo on the right in Figure 12.

When cracks develop in the pedestal, the distribution of load through the pedestal may be significantly disrupted from the original design intentions. Some minor shrinkage cracking is quite common and not considered a concern, often present and showing no signs of progression over many years. At what time after construction shrinkage cracking typically occurs is dependent on several factors including the concrete mix design, weather conditions at the time of placement, and structure location/exposure making it difficult to predict when shrinkage cracking may occur. Most typically, shrinkage cracking occurs shortly after construction to within the first few years of operation. However, any crack is a potential pathway for water to ingress and freeze thaw cycles may accelerate damage. Circumferential cracking is less common and may indicate a structural issue, the Engineer should be consulted if these cracks are observed.

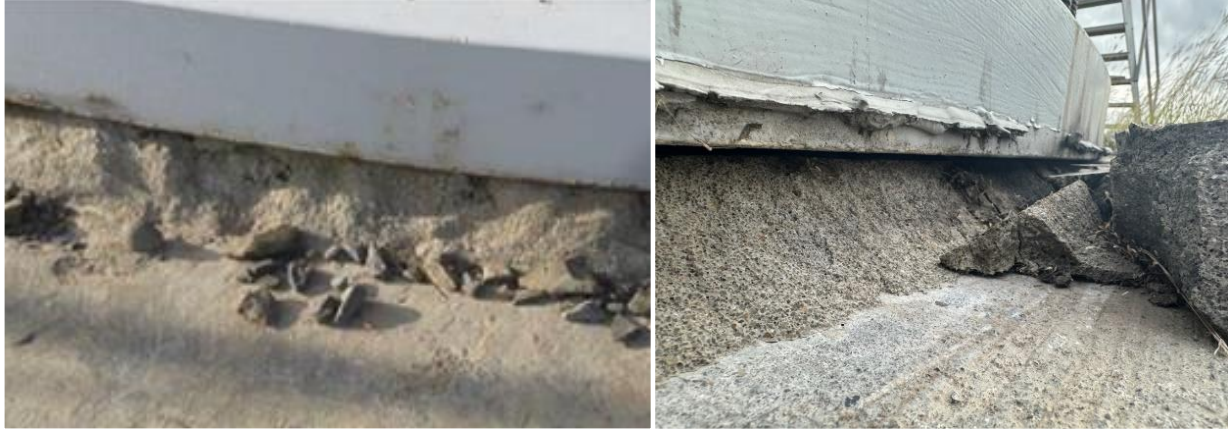
Figure 13. Loss of grout with the potential for gapping shown in the left photo and significant loss of grout with gapping due to low anchor bolt tension shown in right photo.

Tower base flange grout gapping may be caused by grout material deficiencies, inadequate confinement, base flange impact loads, or significant anchor bolt tension loss. Observable gaps between the bottom of the flange and the top of the grout are a concern. Examples of gapping are shown in Figure 13.

Any gap present between the grout and tower flange will result in a change to the intended load path from the tower base flange to the grout resulting in higher than intended stresses on both surfaces. The change in the load path may result in progressive failure of grout or pedestal concrete. Gapping may also be dynamic which is evidenced by detectable displacement of the flange with respect to the grout. **Dynamic gapping is a serious and immediate concern that should be addressed by removing the turbine from service, notifying appropriate stakeholders, and consulting the Engineer.**

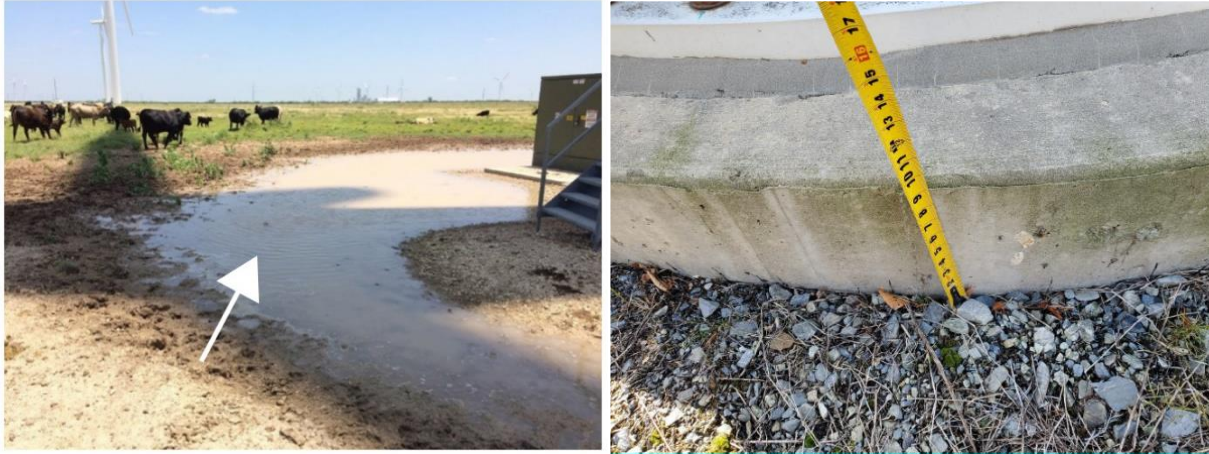
Figure 14. Poor grading resulting in pooling of water in left photo and example of low backfill height in right photo.

Improper grading is any grade condition that does not meet the design specification in the foundation drawings. Grading may fail due to drainage conditions or failure of backfill material for various reasons. The photos below show examples of improper grading.

The majority of foundations rely on backfill to stabilize the foundation. Changes in the backfill and grading can result in less material to resist turbine loading. Additionally, poor grading and drainage can result in ponding of water near the turbine which may change the assumed soil properties in the design as well as present risks to staff maintaining the wind turbine equipment. It is common for the backfill placed over and around a wind turbine foundation to erode over time for various reasons. The backfill is a critical component of the foundation system and should be maintained in accordance with the original foundation drawings and specifications.

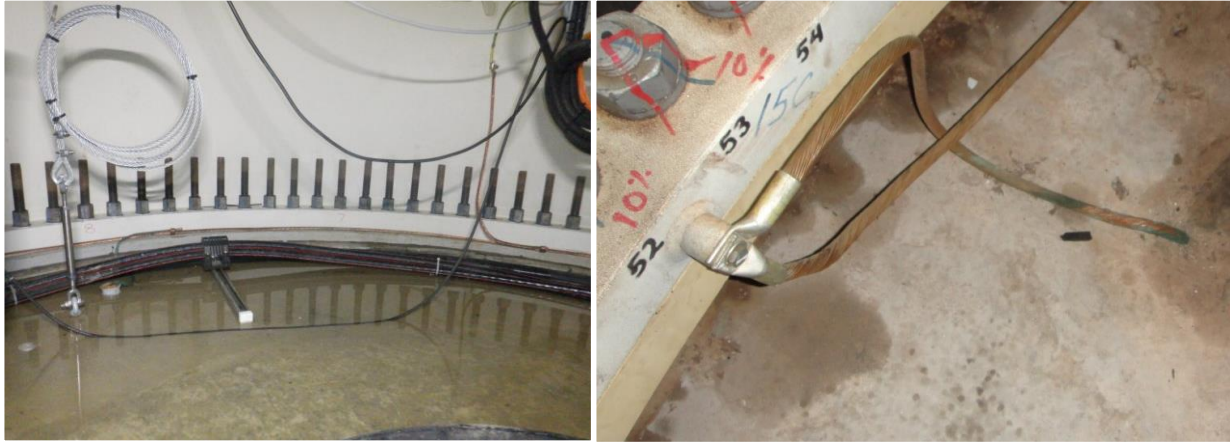
Figure 15. Water pooled shown in left photo and corrosion of grounding cables due to water in the basement shown in left photo.

Water may be found inside the turbine tower on the top surface of the pedestal. This location is often referred to as the “basement” as it is common practice to install a deck above the top surface of the pedestal. Water pooled in this location and the resulting corrosion that can occur on grounding cables is shown in Figure 15.

Water intrusion in coastal environments and areas with numerous freeze-thaw cycles should be prevented. Over time, the freeze-thaw and/or possible saltwater intrusion into the foundation may cause degradation. The foundation is typically designed for these conditions, but other systems like electrical grounding may not be. Water intrusion and pooling in the basement may present a number of issues, the first of which is safety. Water pooled with residue of grease or oil from the turbine presents a slipping hazard. Additionally, water presents many risks with electrical equipment with the majority of wind turbine cable routing through the basement. It is possible that water could provide a path for an electrical fault or expose a worker to an electrical hazard. Water, even in small quantities, also accelerates corrosion. Bonding and grounding of the tower to the foundation is typically done with a metallic conductor which is susceptible to corrosion. Additionally, the tower base flange when exposed to corrosive conditions is susceptible to corrosion and potential failure.

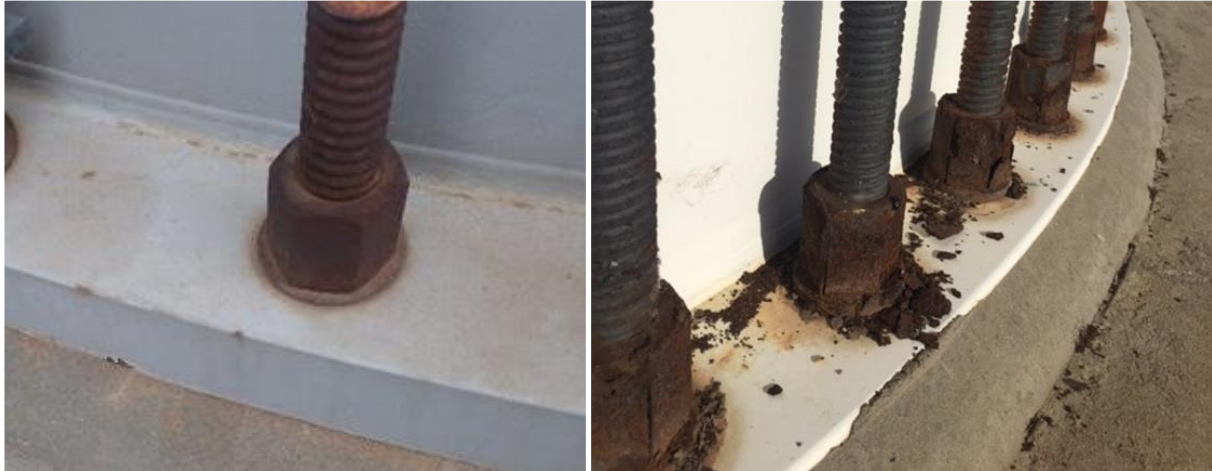
Figure 16. Hardware with surface corrosion is shown in the left photo and hardware with advanced corrosion is shown in the right photo.

Most hardware utilized in wind turbine foundations is steel. When galvanized steel is used, hardware corrosion is greatly reduced, but it is not commonly used at wind plants in North America. The potential for corrosion of steel is greater in areas with environmental conditions that promote oxidization such as higher moisture levels or presence of other chemicals which may be man-made or naturally occurring. Figure 16 shows two examples of hardware corrosion. The left photo shows surface level corrosion of anchor hardware in a relatively dry environment. The right photo is an example of hardware from a wind plant located near a marine environment which has advanced corrosion. Note, the anchor bolts in the left photo did not have anchor bolt covers whereas the bolts on the right did. Corrosion of hardware may result in material loss and reduction of hardware strength, seizing of nuts to the anchor bolt and potential loss of anchor bolt tension.

The purpose of anchor bolt hardware is to maintain the pretension in the anchor bolt as well as retain the tower flange under expected loading, so long as degradation of hardware does not reduce the anchor bolt tension or strength of the anchor bolts below the design requirements, corrosion does not present a performance issue. However, when corrosion prevents the smooth operation of the hardware, verifying anchor bolt tension becomes more difficult. If corrosion is prevented to ensure the serviceability of the anchor bolt hardware, more advanced issues like loss of strength and tension are significantly minimized.

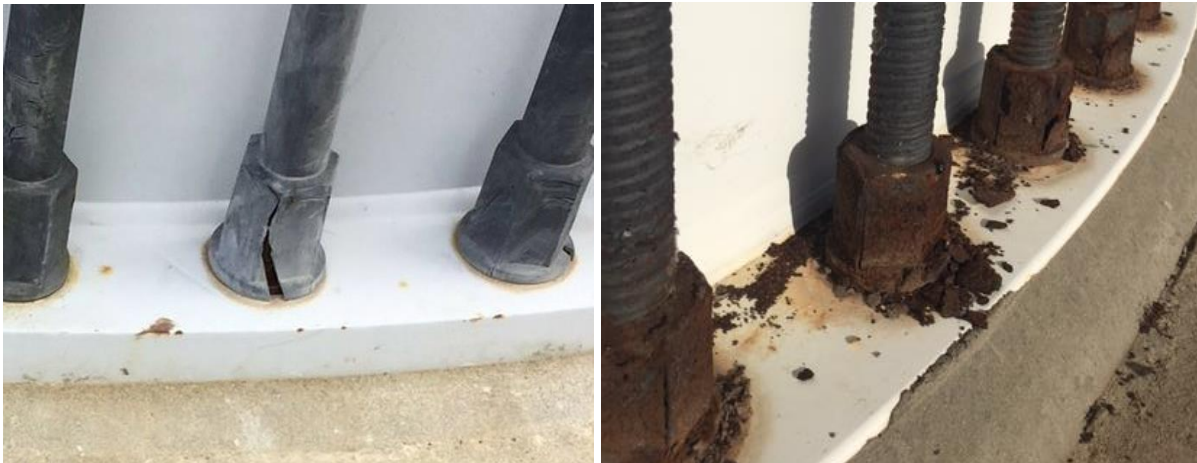
Figure 17. Cracked bolt cover shown in the left photo and a bolt and nut with the cover removed wherein water was being trapped resulting in corrosion of the lower portion of the nut is shown in the right photo.

Anchor bolt covers are utilized in combination with grease to prevent corrosion of bolted hardware in many industrial applications. Bolt covers are intended to prevent grease from washing away due to environmental factors like wind and rain. Bolt covers are however susceptible to damage from debris/impact and cracking typically due to UV exposure. They may also fail to perform their intended function due to misapplication or poor design. When anchor bolt covers fit too tightly around the nut, they can retain moisture and can result in increased corrosion, potentially more than if none were used at all. Figure 17 shows examples of both common issues discussed.

The impact of failed anchor bolt covers is an increase in the risk of hardware corrosion and the associated problems mentioned in section 8.8 above. The recommended preventative maintenance to mitigate bolt cover failure is a visual inspection and to replace failed anchor bolt covers when found.

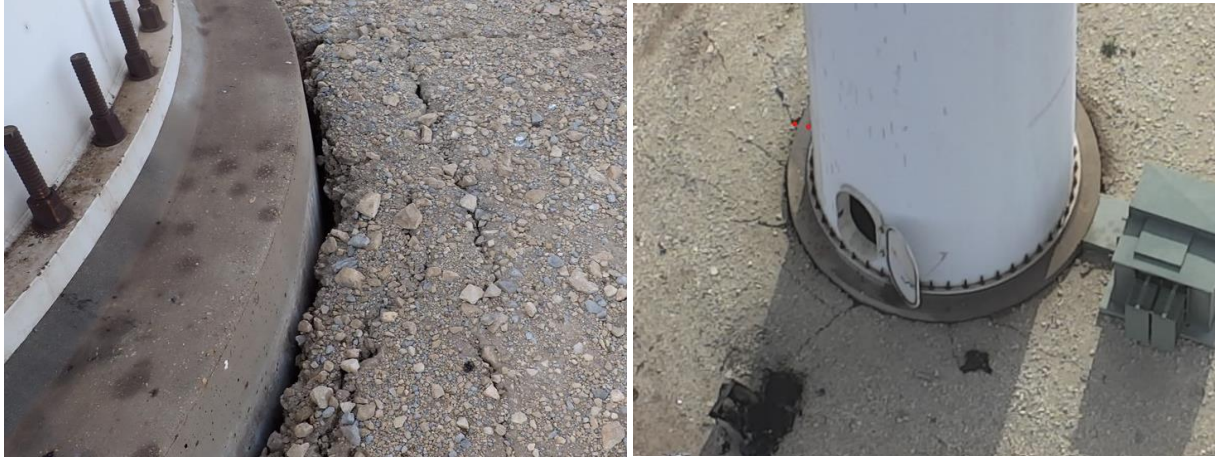
Figure 18. Gap between pedestal and backfill from close-up in left photo and aerial view of foundation soil cracking in right photo.

The figures below show soil conditions that were due to a foundation overload that resulted in foundation uplift which disturbed the backfill and resulted in radial soil cracking and significant gapping around the pedestal. After inspection, this foundation was found to have a significant anchorage pullout failure.

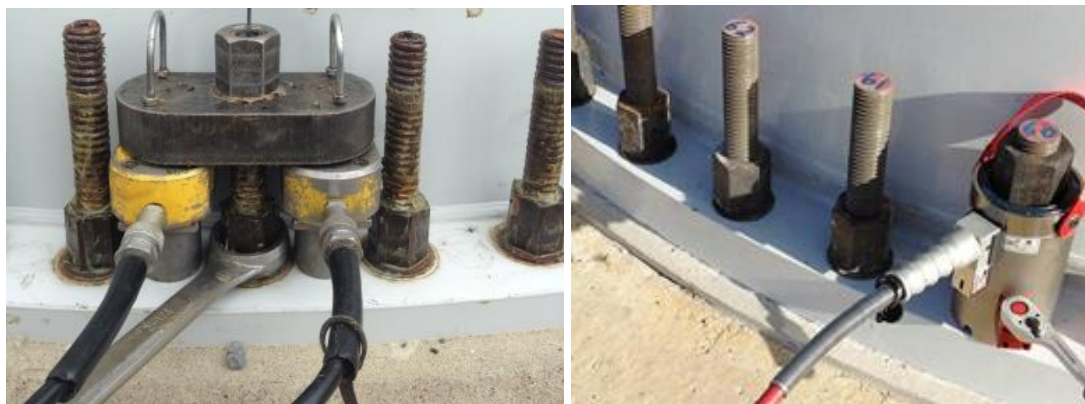
Figure 19. Jack and plate tension method setup shown in left photo and bolt tensioner on an anchor bolt in the right photo [ITH Bolting Technology, www.ith.com].

Anchor bolt tension that is below the design pretension can result in damage to the foundation, anchor bolts and grout. Low anchor bolt tension is not visible to the naked eye unless the tension is so low that gapping occurs under normal loading conditions. Anchor bolt tension is typically identified using mechanical means to apply the prescribed tension and evaluating the response of the hardware by evaluating the bolt extension or checking for nut liftoff. Nut liftoff is achieved by overcoming the existing tension present in the anchor bolt and at that higher applied tension the anchor bolt nut will separate from the washer, or the washer will separate from the tower base flange.

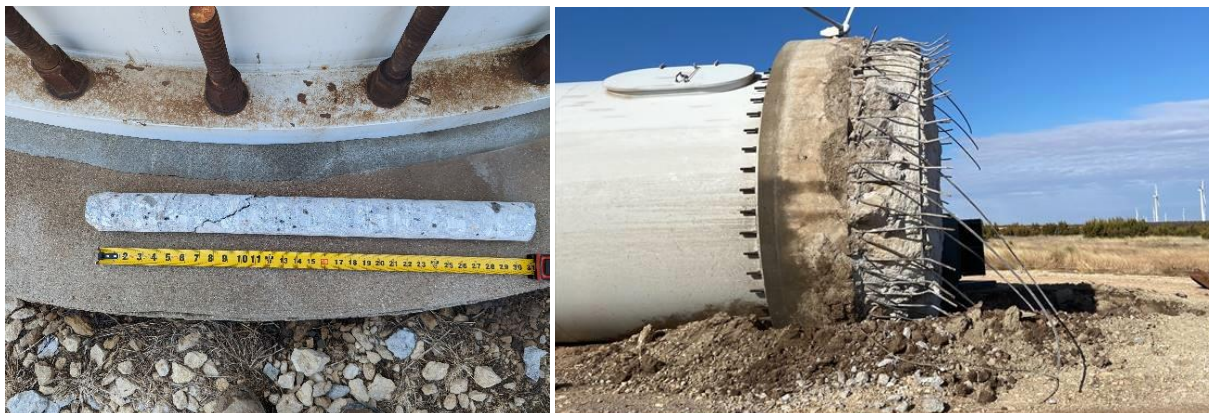
Figure 2019. Cracked concrete core taken at the anchorage pullout area in the left photo, turbine collapse due to foundation overloading event and anchorage pullout failure in the right photo.

One potential failure mode of a typical gravity-based spread footing foundation is cracking/damage of the area around the anchor bolt cage within the foundation due to the transfer of load from the embedment plate into the foundation. High load events or excessive fatigue loads may cause this type of failure that is more relevant to older foundation designs as discussed in further detail in Section 8.9 below. The left photo below shows a less progressed failure of the anchorage pullout due to an overloading event in a concrete core extracted from the anchorage zone. The right photo shows a turbine collapse resulting from an overloading event and subsequent failure of the anchorage pullout area.

Foundation performance due to this type of damage varies based on the level of concrete cracking/damage within the foundation. Early stages of this failure may not be detectable due to backfill covering the area. Slightly progressed damage may result in excessive turbine movement causing faults, while the most advanced stages of damage may result in foundation failure. Structural health monitoring (SHM - Section 10.8) can be installed to detect signs of stiffness loss, serving as a predictive tool for concrete crack formation in the anchorage pullout failure area.

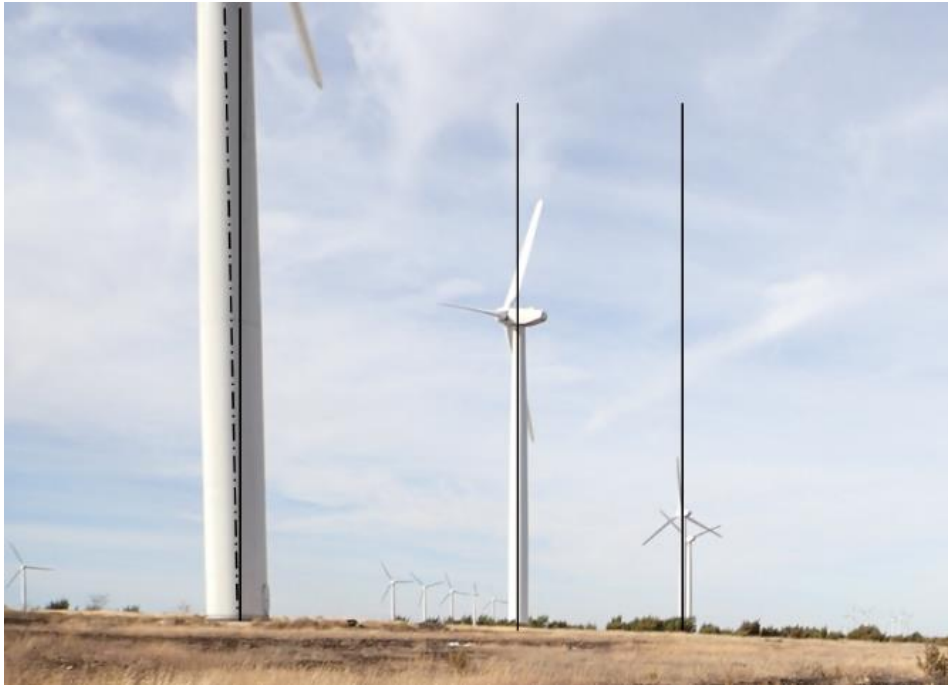
Figure 21. Example of a foundation out of level resulting in visually observable tower tilt compared to neighboring turbines. Solid vertical lines are drawn representing two plumb and vertical towers to the right whereas the tower on the left has a tower centerline, shown with a dashed line, that is not plumb.

While the soil properties are carefully studied before siting and designing a foundation, it is possible for foundations to become out of level. Common reasons for foundations to lose their initial level condition are settling and overload events. Regardless of the cause, an out of level foundation is a serious structural concern. If a foundation is suspected to be out of level, the turbine should be taken out of service and the Engineer should be contacted to schedule an inspection. A common approach often recommended is to conduct a professional survey.

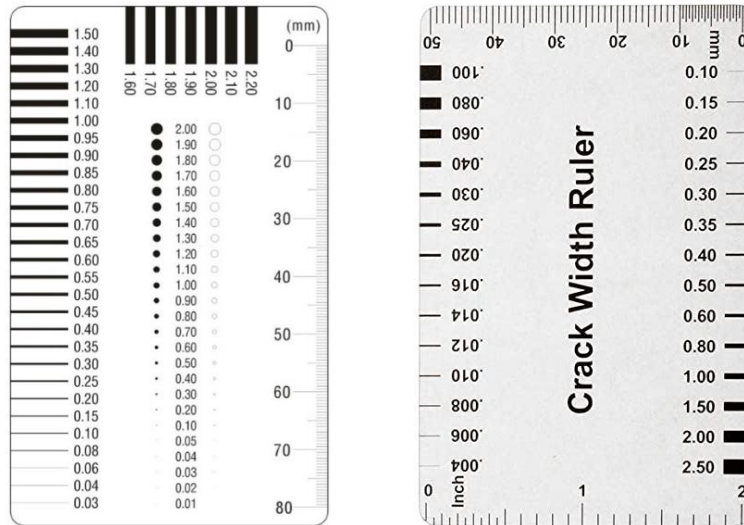
Figure 22. Examples of typical crack width gauges, material is thin clear plastic with black print and are commonly in both inches and millimeters.
