Onshore Wind Turbine Foundation Maintenance: RP 401

Recommended Practices for Onshore Wind Turbine Foundation Maintenance (RP 401)

- **Purpose:** Provide detailed recommendations for inspection, maintenance and repair of wind turbine foundations.
- **Working Group Members:**
 - Jesse Tarr – Wind Secure
 - Wesley Karras – Barr Engineering
 - Coral Rodriguez – RWE
 - Ron Grife – Leeward Renewable Energy (Chair)
- **Link:** <https://cleanpower.org/resources/recommended-practices-for-onshore-wind-turbine-foundation-maintenance/>

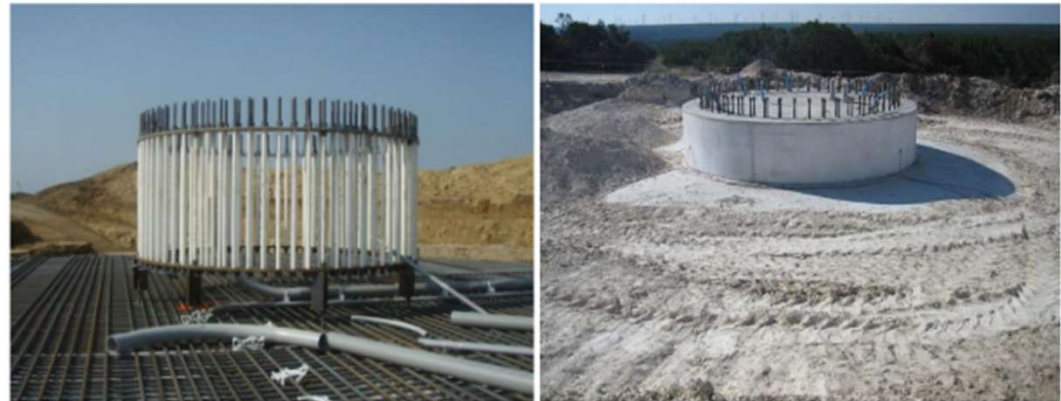
Figure 7. Anchor bolt/embedment plate assembly prior to concrete placement shown in left photo and fully constructed foundation in the right photo.

An anchor bolt/embedment plate assembly is the most common type of connection made between the tower and the foundation. The anchor bolts are tensioned after concrete curing primarily to minimize fatigue of the anchor bolts. However, in the case of a tensionless tube foundation, the anchor bolts also provide pre-tensioned reinforced concrete strength. Figure 7 shows an anchor bolt embedment plate assembly during and after construction.

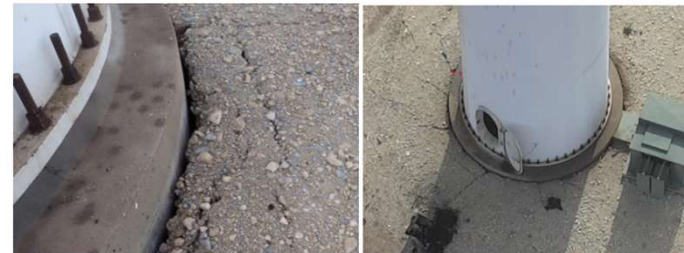
The figures below show soil conditions that were due to a foundation overload that resulted in foundation uplift which disturbed the backfill and resulted in radial soil cracking and significant gapping around the pedestal. After inspection, this foundation was found to have a significant anchorage pullout failure.

Figure 18. Gap between pedestal and backfill from close-up in left photo and aerial view of foundation soil cracking in right photo.

The recommended preventive activity to mitigate the impact of these failure modes is visual inspection and training turbine maintenance crews to look for this defect during regular turbine maintenance visits and after significant loading events discussed in Section 10. If these conditions are observed and cannot be attributed to normal soil conditions, the recommended action is to remove the machine from service and contact the Engineer. **Note: Failure to act could result in foundation collapse.**

If the condition is a result of excessive loading or unstable soil conditions, corrective measures must be taken to ensure the stability of the structure. The resolution of these issues is varied and requires assessment by the Engineer to determine a corrective action plan.

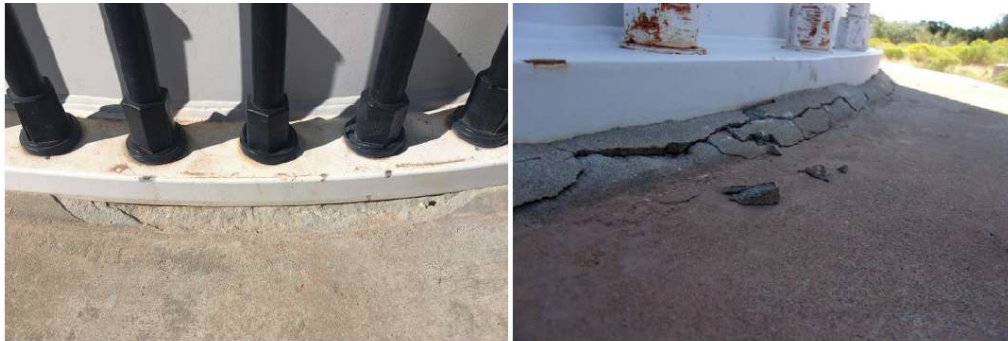
Grout spalling

Figure 9. Early-stage spalling in left photo and late-stage spalling with significant cracking in right photo.

Ref. Section	Failure Mode	Effect on System	Impact	Recommended Preventative Maintenance
8.1	Grout - Spalling	Load from the tower flange is not evenly distributed to the foundation.	Tension of anchor bolts is potentially reduced. Grout continues to fail over time. Without repair, gapping can occur between grout and flange resulting in further structural damage.	Visual inspection of internal and external grout, repair of spalled grout.

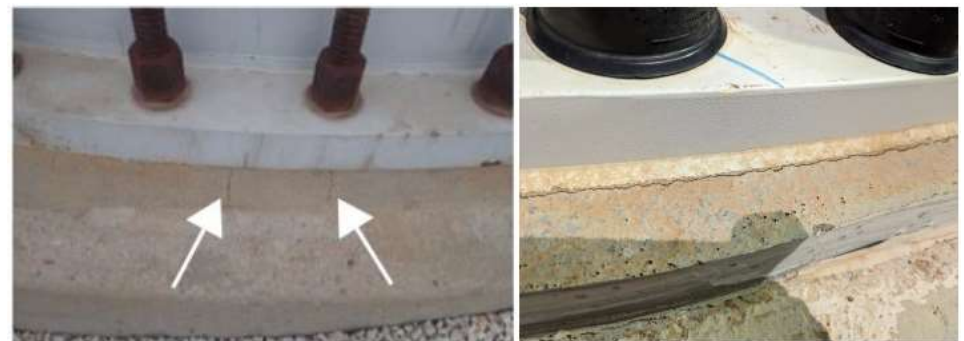
Grout cracking

Figure 10. Radial cracking in cementitious grout in left photo and circumferential cracking in epoxy grout shown in right photo.

8.2	Grout - Cracking	No immediate effect to foundation function so long as grout is consolidated. However, significant cracks could be a sign of grout failure.	Cracking may continue through freeze-thaw cycles and lead to spalling.	Visual inspection of internal and external grout, filling of cracks over 0.3mm (0.012"). Cracks larger than 2.0mm (0.08") are significant and could be a sign of more critical issues.

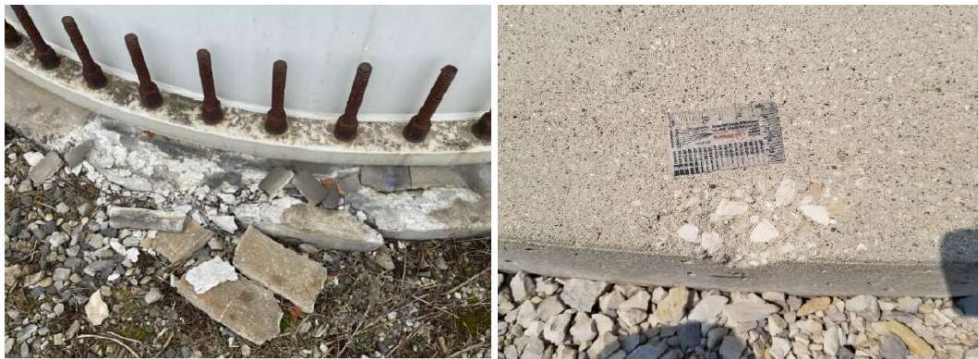
Pedestal spalling

Figure 11. Structurally significant pedestal spalling in left photo and minor debris/impact pedestal spalling in right photo.

8.3	Pedestal - Spalling	Load from grout is not evenly distributed to the foundation.	Tension of bolts is potentially reduced. Concrete continues to fail over time. Without repair, further structural damage can occur. Reduced reinforcement concrete cover.	Visual inspection of internal and external pedestal concrete, repair of spalled concrete.

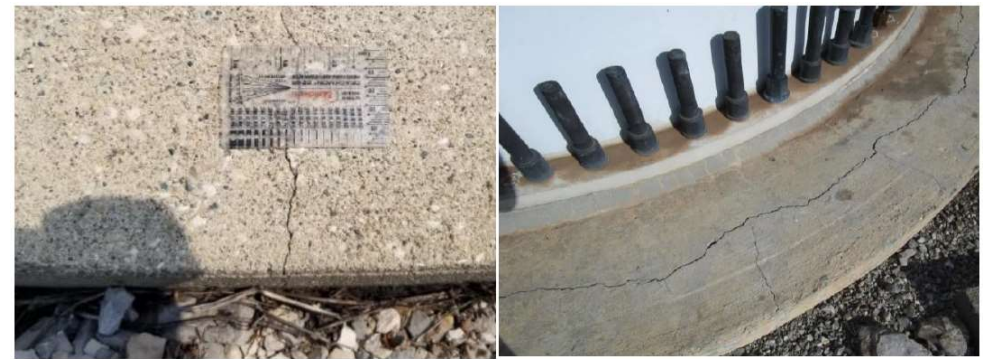
Pedestal cracking

Figure 12. Pedestal radial shrinkage crack in left photo and more significant circumferential cracking in the right photo.

8.4	Pedestal - Cracking	No immediate effect to foundation function. However, significant cracks could be a sign of pedestal failure.	Cracking may continue through freeze thaw cycles and lead to spalling.	Visual inspection of pedestal both internal and external, filling of cracks over 0.3mm (0.012"). Cracks larger than 2.0mm (0.08") are significant and could be a sign of more critical issues.

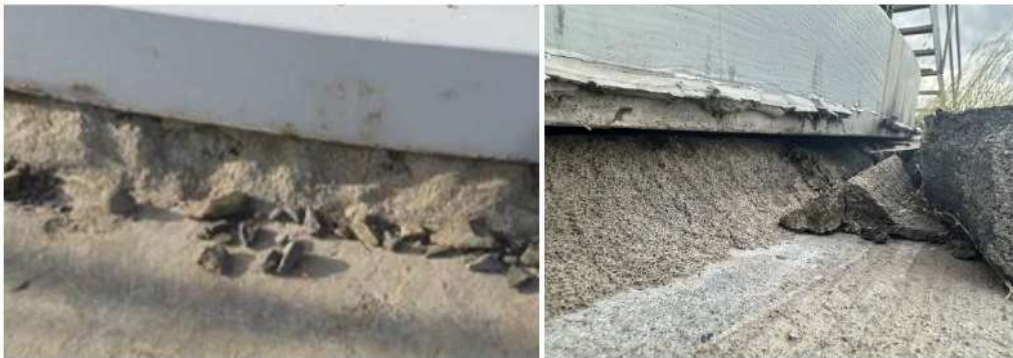
Grout loss under flange

Figure 13. Loss of grout with the potential for gapping shown in the left photo and significant loss of grout with gapping due to low anchor bolt tension shown in right photo.

8.5	Tower Base Flange to Grout Gapping	If gapping at the flange is present, the loads generated may be outside of the design assumption for the foundation.	Fatigue cycling of the foundation bolts may occur. Cracking of the grout and pedestal are likely to occur.	Visual inspection and repair of conditions leading to gapping. If gapping is suspected, a thin object such as a piece of paper or plastic can be used to gage the size of a gapping area.

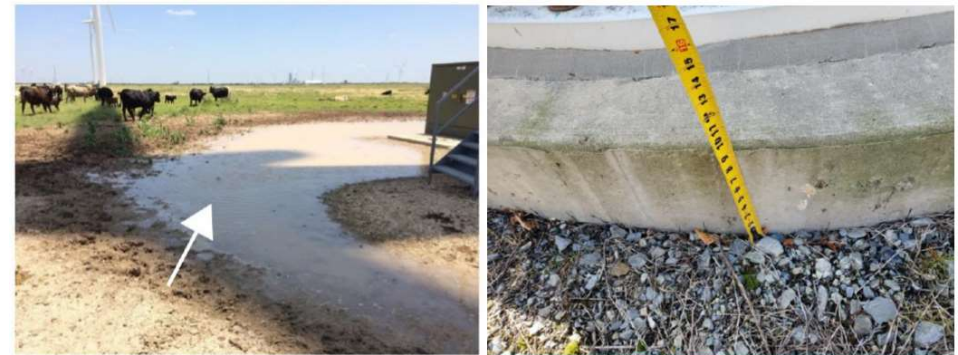
Poor grading/backfill loss

Figure 14. Poor grading resulting in pooling of water in left photo and example of low backfill height in right photo.

8.6	Improper Grading	Amount of material resisting overturning loads may not meet engineering design criteria.	Grading resulting in ponding of water.	Visual inspection to check the grading meets engineering specification and there are no signs of ponding. Correct grading issues if present.

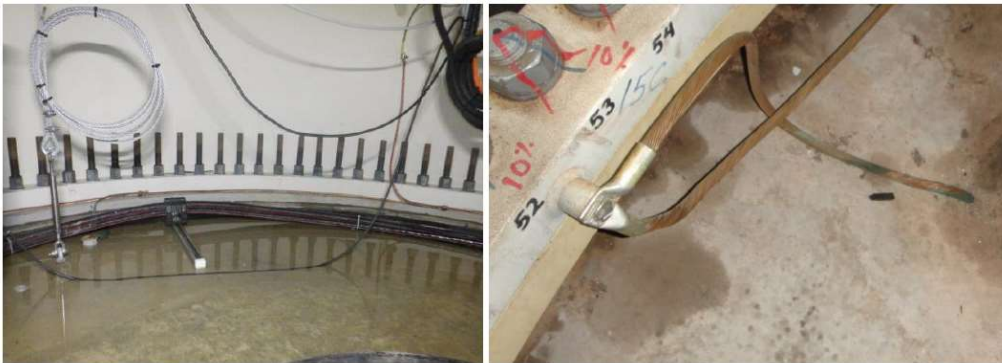
Water pooling

Figure 15. Water pooled shown in left photo and corrosion of grounding cables due to water in the basement shown in left photo.

Ref. Section	Failure Mode	Effect on System	Impact	Recommended Preventative Maintenance
8.7	Water in Basement	No likely impact on structural loads.	Corrosion of internal hardware including steel tower components, electrical ground cables	Inspect basement for water ingress and correct if found.

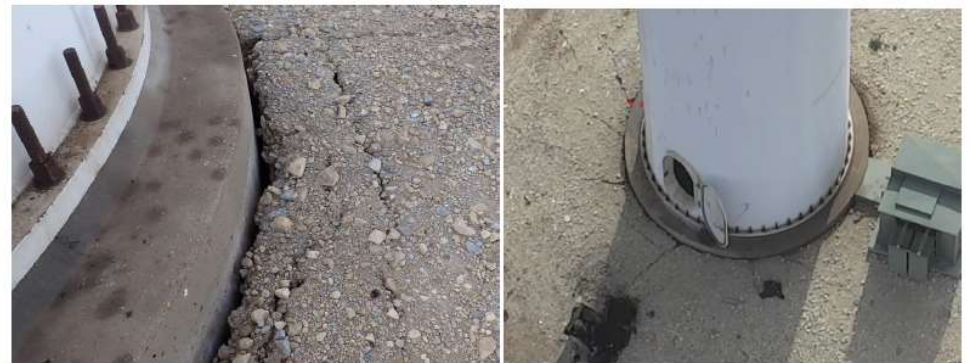
Soil gapping/cracking

Figure 18. Gap between pedestal and backfill from close-up in left photo and aerial view of foundation soil cracking in right photo.

8.9	Improperly Functioning Anchor Bolt Covers	No immediate effect to foundation loads.	Anchor bolt corrosion.	Install anchor bolt covers.
8.10	Soil Cracking and/or Gapping	Indication of possible foundation movement.	Impact on turbine operation and possible failure of foundation. May allow storm water infiltration and potential tilting on tensionless tube design.	Visual inspection and backfilling with compacted soils.

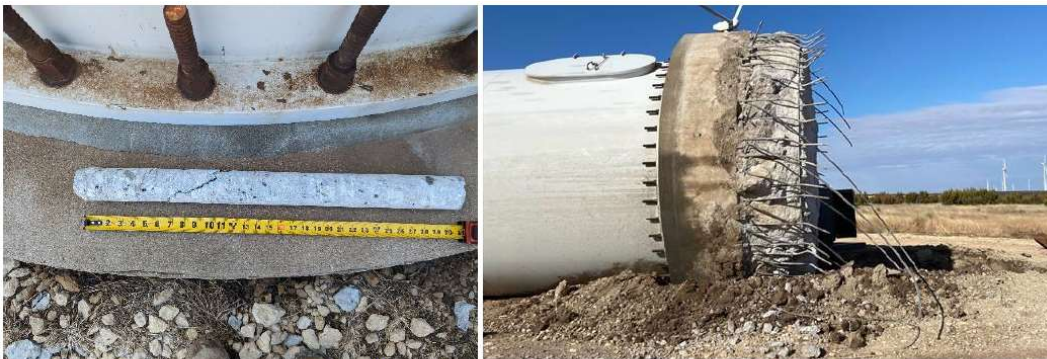
Anchorage zone damage

Figure 2019. Cracked concrete core taken at the anchorage pullout area in the left photo, turbine collapse due to foundation overloading event and anchorage pullout failure in the right photo.

8.13	Anchorage Pullout Failure	The foundation is not able to support turbine loads.	Possible failure of foundation.	Structural health monitoring, coring, below grade inspections or other method at frequency determined by Engineer.

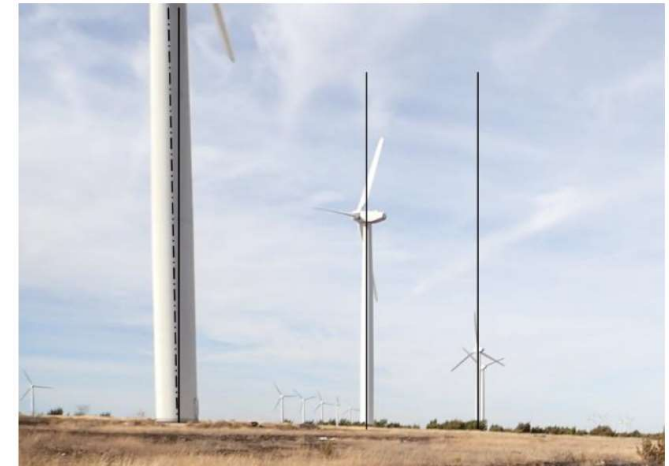
Foundation out of level

Figure 21. Example of a foundation out of level resulting in visually observable tower tilt compared to neighboring turbines. Solid vertical lines are drawn representing two plumb and vertical towers to the right whereas the tower on the left has a tower centerline, shown with a dashed line, that is not plumb.

8.14	Foundation Out of Level	Reactive loads transferred to vertical rebar.	Vertical rebar may fail if foundation design is not adequate for fatigue.	Survey or SHM.

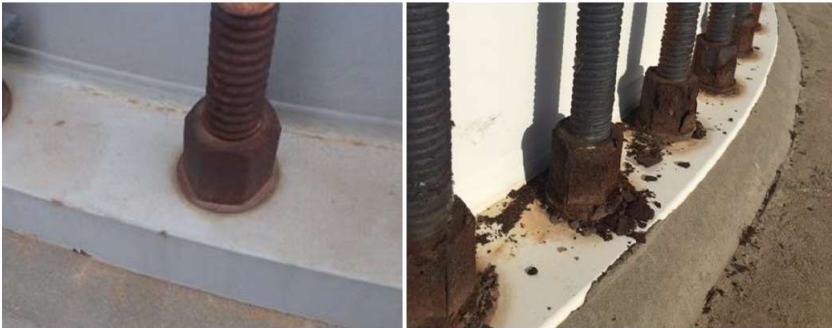
Anchor bolt hardware corrosion

Figure 16. Hardware with surface corrosion is shown in the left photo and hardware with advanced corrosion is shown in the right photo.

8.8	Hardware Corrosion	No immediate effect to foundation loads.	Degradation of hardware: anchor bolt, nut, and washer potential section loss. Nuts seized to the bolt. Bolts not holding design tension. Washers failing over the lifetime could lead to oscillating loads on the base bolts affecting the fatigue lifetime of the foundations.	Apply approved systems for corrosion protection to all interior and exterior anchor bolts, nuts, and washers such as grease or coatings.

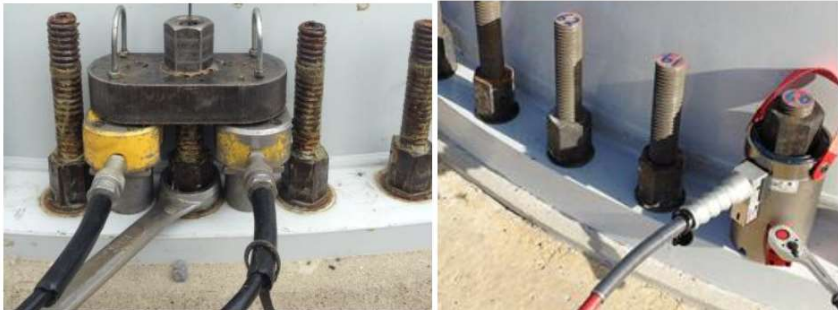
Figure 19. Jack and plate tension method setup shown in left photo and bolt tensioner on an anchor bolt in the right photo [ITH Bolting Technology, www.ith.com].

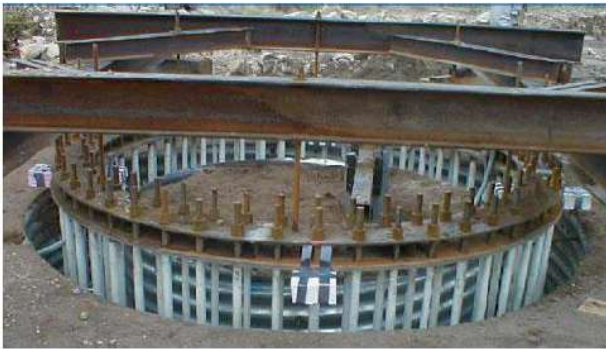
Tensionless tub/P&H

Figure 3. Tensionless tube foundation anchor cage ready for pour in left photo, and three-dimensional image illustrating the design elements of the tensionless tube foundation in the right photo.

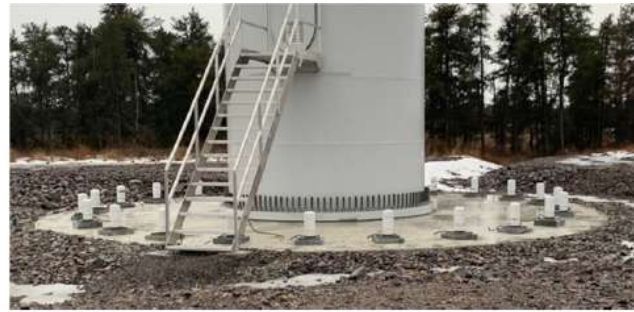
Figure 4. Rock anchor foundation in service in left photo, and three-dimensional image illustrating the design elements of the rock anchor foundation in the right photo.

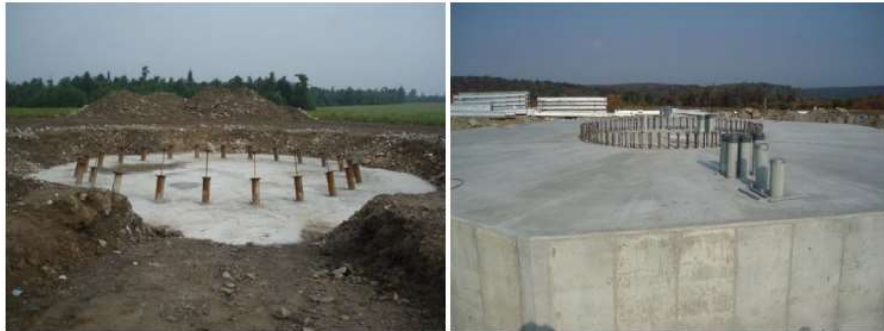
Figure 5. Pile supported cap foundation in construction in left photo and completed foundation in right photo.
