# Gearbox Operations Playbook

The American Clean Power Association (ACP)'s Drivetrain Working Group developed the ACP Gearbox Operations Playbook, with the intent to provide guidance for day to day operations of wind turbine gearboxes. Common troubleshooting scenarios and solutions will be discussed. The Drivetrain Working Group represents decades worth of expertise and experience, gained from both wind and other industry sectors. The group's objective is to inform, train and support wind industry technicians, engineers and managers in their efforts to improve reliability and project performance.

The information in this document provides high level guidelines for failure mode identification, maintenance, monitoring, and inspection of wind turbine gearboxes. Common troubleshooting scenarios and solutions to those scenarios will be addressed. These contents will best support those who are being introduced to the wind industry or the operation of wind turbine drivetrains.

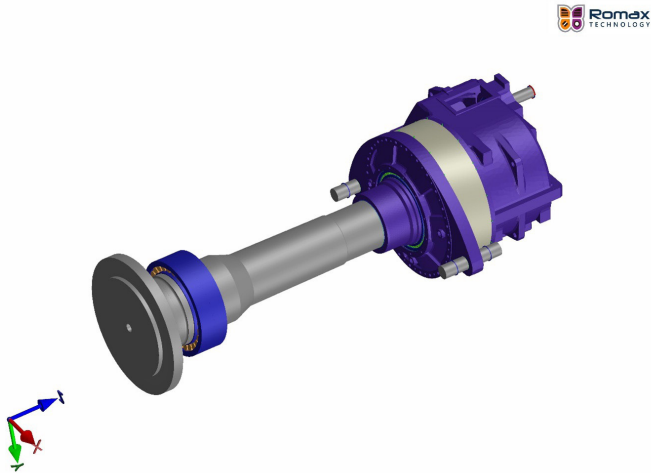
## 1. Three Point Mounted Drivetrain:

The Drivetrain is mounted to the bedplate of the nacelle via generator, gearbox, and one main shaft bearing.

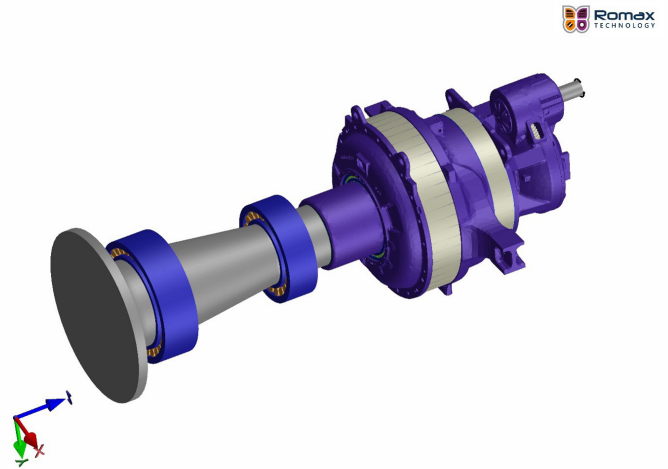
## 2. Four Point Mounted Drivetrain:

The Drivetrain is mounted to the bedplate of the nacelle via generator, gearbox, and two main shaft bearings.

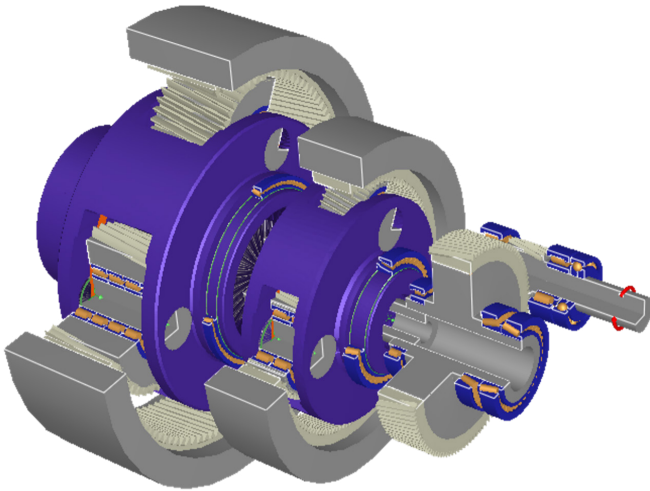
1. Two planet stages and a single stage parallel section.

Today, most wind turbines utilize one of three common gearbox configurations. These configurations are (the upwind side of the gearbox is on the lefthand side of the below images):

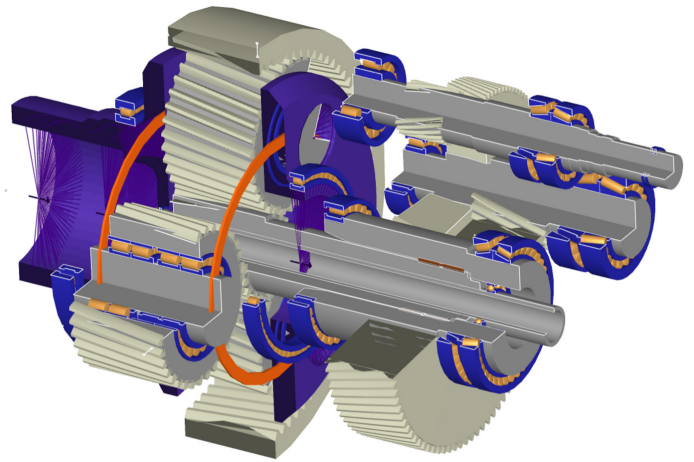
2. One planet stage and a two-stage parallel section.

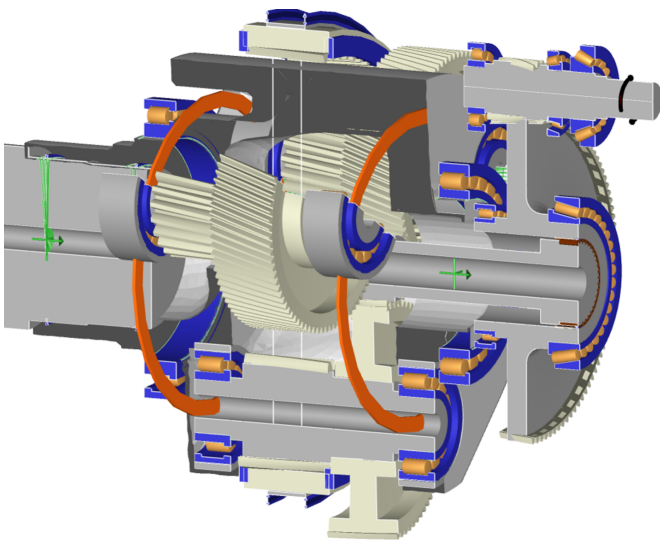
3. Compound planet stage and a single stage parallel section.

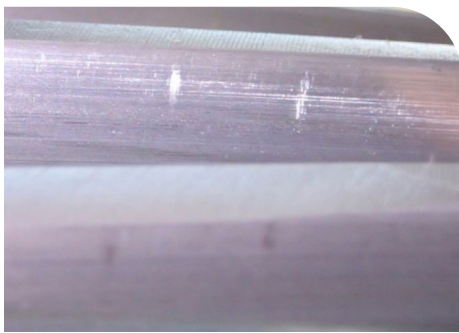
Transfer of material from one gear to the mating gear through micro-welding. Appears shiny and irregularly shaped. This type of damage is typical wear for gears. If adhesion does not progress to pitting, there is minimal concern of impact to daily operations.

Figure 1: Gear teeth with mild adhesion

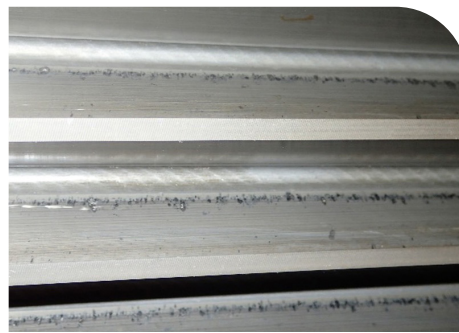
The removal/displacement of gear material due to the presence of hard particles between the teeth. Abrasion can have a darker appearance on the tooth flank or appear as dents or small pits. If the abrasion does not progress to more severe damage, such as pitting or spalling, there is minimal concern of impact to daily operations.

Figure 2: Gear teeth with mild abrasion

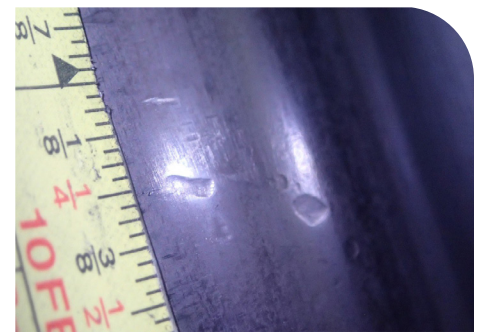
Figure 3: Abrasion in the form of denting on the tooth flank

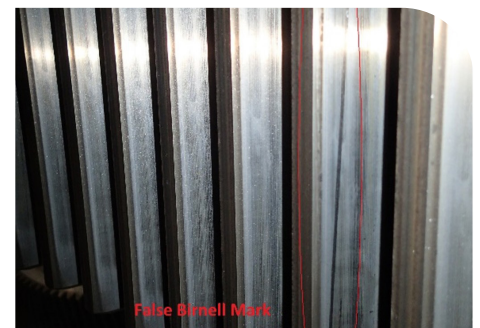
This occurs when mating gears are subject to an impact load or smaller oscillating load while the gearbox is not rotating (at standstill). False brinelling usually occurs during transportation of the gearbox or up-tower when the rotor is locked out and the gearing is isolated to small relative motion between mating components. The two mating surfaces polish each other in a line that travels non-parallel to the tooth flank (caused by the helix angles of the teeth). False Brinell marks will often be accompanied by fretting corrosion. These marks typically have little to no impact to operations. However, in rare cases, false Brinell marks can be severe enough to form pitting along their length. This pitting should be monitored for progression regularly. If these marks progress to more severe failure modes, such as macro pitting or spalling, the gear will eventually need to be replaced.

Figure 4: False Brinell Mark

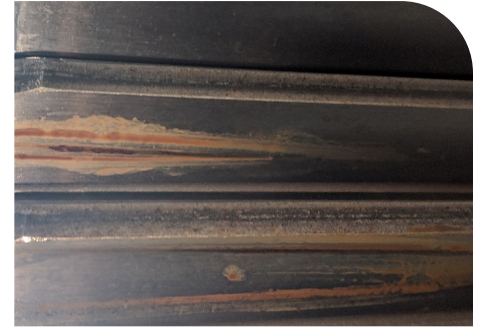
Like false brinelling, this is caused by small oscillating (or cyclic) loading in which the movement between the parts is small. The mating gears cause adhesion. The debris produces an iron oxide powder, resulting in the reddish colors in Figure 5. Fretting corrosion will almost always be found accompanying a false Brinell mark. In most cases, the corrosion will be wiped away when normal operation resumes. In some cases, if the corrosion has time to set in, it will form pits along the area of the tooth subjected to the corrosion. If this occurs, and the pits become progressive, the gear will eventually need to be replaced.

Figure 5: False Brinell Mark with Fretting Corrosion

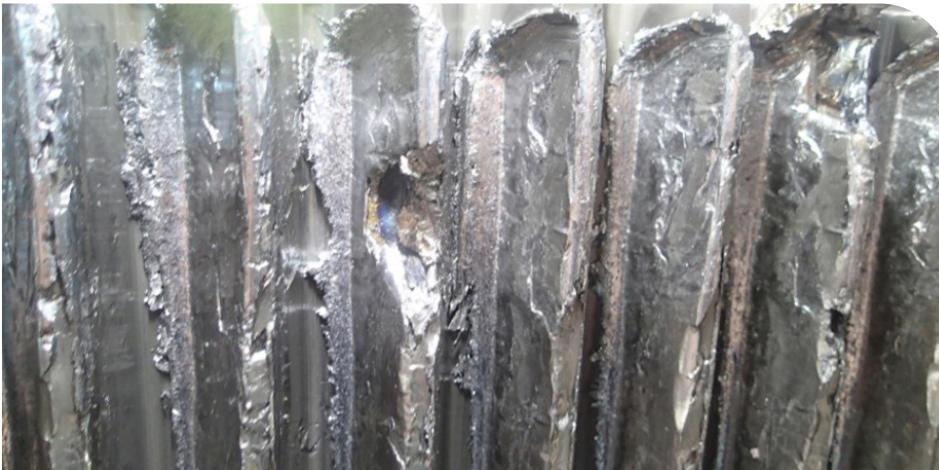
This is permanent deformation of teeth due to overstressing the material. It can be the result of overload, debris interference, or some other factors. Plastic deformation of any gear will lead to premature failure, and the gear will need to be replaced.

Figure 6: Plastic deformation known as cold flow. In this case the planets interfered with the ring gear tips, pushing the ring gear material toward the root as the planets were rotating.

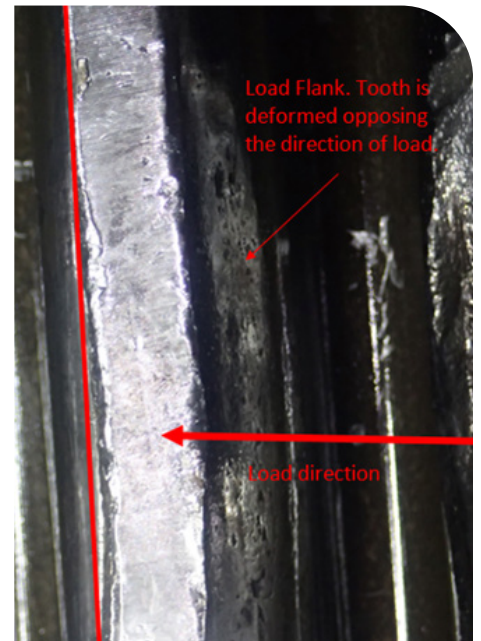
Figure 7: Example of a tooth plastically deformed due to debris

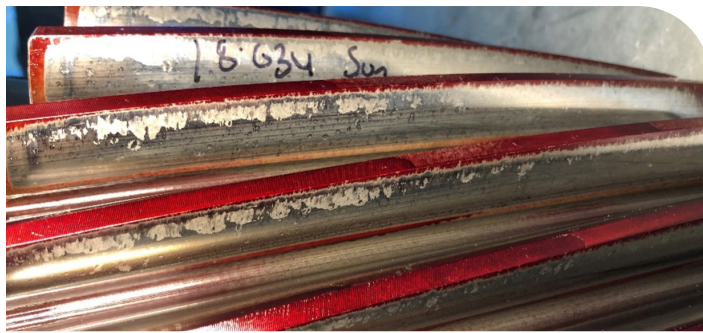
Also known as gray staining. Gives a gray appearance and normally has an irregular shape. The gray appearance is due to thousands of microscopic pits coalescing into larger areas of surface damage. This damage is driven by the removal of asperities from the tooth surface. Micro pitting can be progressive if severe enough and can signal issues with the effectiveness of oil lubrication or loading on the contact surface. If found, the gear should be periodically checked. If micro pitting is not progressive, operation may continue as normal. If micro pitting does become progressive, the surface defect will eventually lead to macro pitting or spalling, at which point the gear will eventually need to be replaced.

Figure 8: Micro pitting along addenda of gear teeth

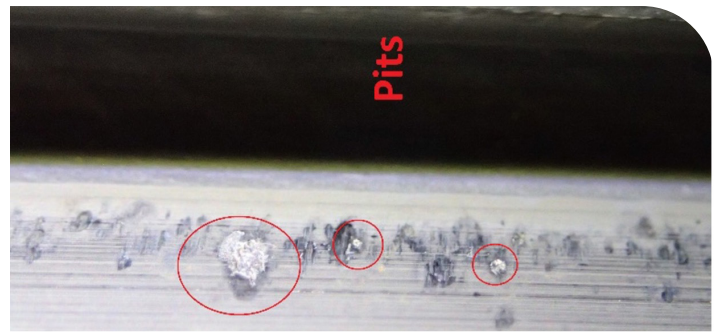
This failure mode appears jagged and reflects more light than micro pitting, resulting in a shinier appearance. The loss of material is accompanied by microcracks in and around the damaged area. This damage usually forms on its own but can also form from severely progressed micro pitting. Once macro pitting has begun the gear will eventually need to be replaced.

Figure 9: Examples of macro pits on a gear tooth

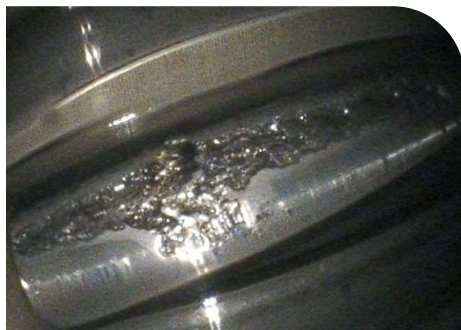
This failure mode is initiated by stress concentrations caused by existing surface defects. Progressed macro pitting can sometimes initiate spalling. Spalling can vary in size and depth, but once this failure mode has initiated the replacement of the gear will need to be prioritized.

Figure 10: Spalling damage initiated from surface damage at the dedendum of a gear tooth.

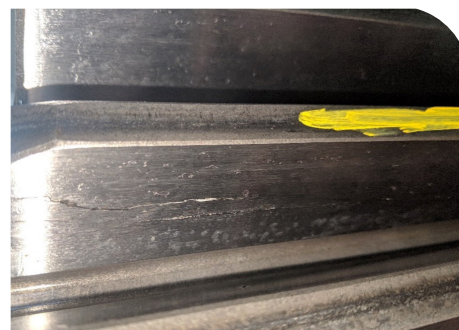
Cracks are visible separation of material within itself. Cracks will lead to full fracture of the tooth, but in some cases, if caught early enough, the tooth may still be found intact. This is optimal to find the cause of the failure. If a crack is found, the gear will eventually need to be replaced.

Figure 11: Example of a cracked tooth that is still intact

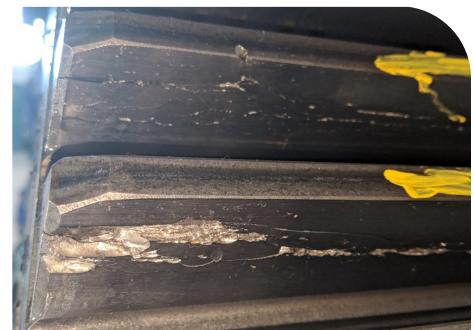
Figure 12: Example of two cracked teeth, one has progressed enough to remove areas of the surface material, the other is not as progressed.

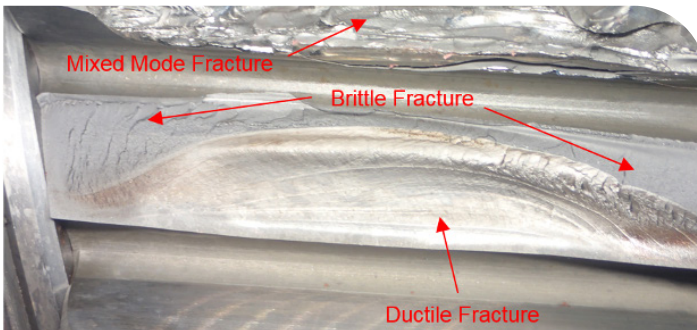
Appear smooth, shiny, and almost always will be accompanied by fatigue lines (aka beach marks). These beach marks are evidence of the slow progression of the crack through one side of the tooth to the other, until it has grown far enough for the tooth to be liberated from its base completely.

Figure 13: Fracture showing Ductile and Brittle fracture on one tooth, with mixed mode fracture on the adjacent tooth.

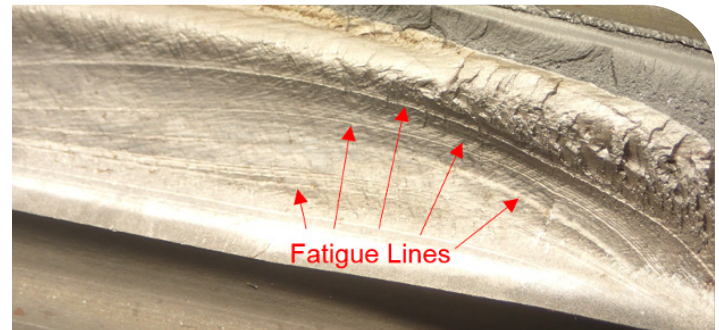
Figure 14: Close up of failure in Fig 13. Fatigue lines (beach marks) are shown for clarification.

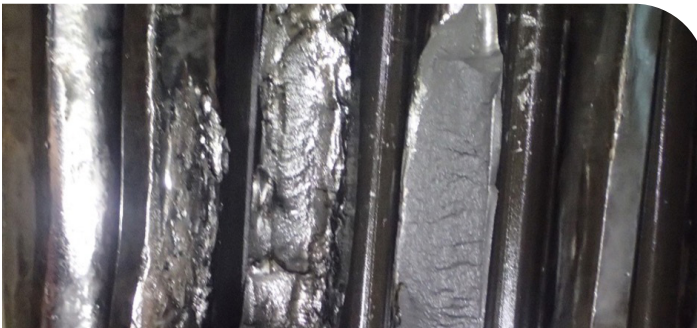
Usually rough, jagged, and gray. They occur due to a few short overload cycles of the tooth in which the crack is forced to propagate quickly.

Figure 15: Completely brittle fracture on the tooth to the far right, causing mixed mode fracture of the tooth behind it. Total brittle fractures due to one load cycle are also known as tooth shear.

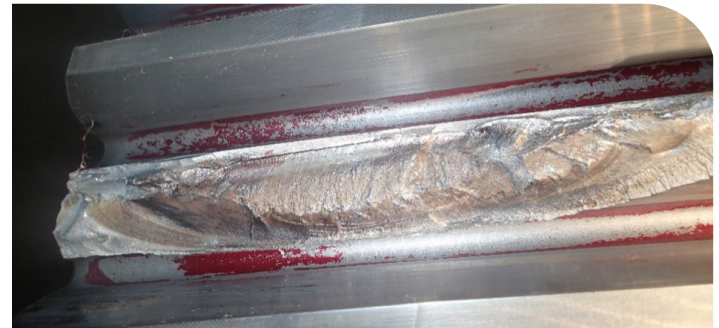
Incorporate both ductile and brittle fractures. Usually caused by severe overload that initiates a crack in a brittle fashion. Subsequent loads will then propagate the crack in a ductile fashion. These modes can often alternate until the tooth has fully liberated.

Figure 16: Mixed mode. Mostly brittle fracture shown, as the tooth was overloaded almost to the point of fracture, then the crack propagated in a ductile fashion during subsequent loads until liberation.

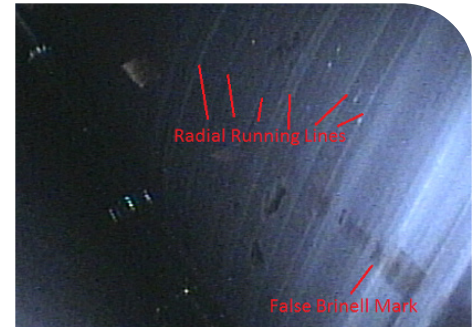
These are like false brinell marks found on gearing and are caused by the same factors. These marks appear straight across the roller and/or race as that is the contact line for bearings (whereas the gears are mostly helical). As with gearing, false Brinell marks on bearings can be accompanied by fretting corrosion. If pitting has not formed from either the false Brinell mark or fretting corrosion, the bearing will be fine to continue operation. If pitting is found, the bearing will need to be checked periodically for signs of progression. If the pitting is progressing, or has turned into spalling, then the bearing will eventually need to be replaced.

Figure 17: Bearing roller with typical radial running lines and a false Brinell mark. Debris dents can also be seen on the roller.

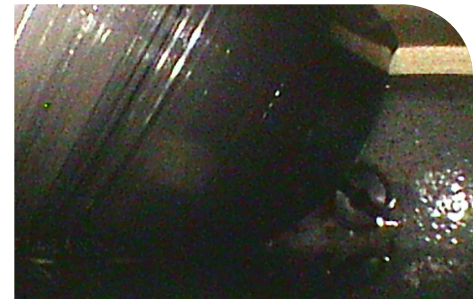
These lines are caused by small debris particles temporarily lodging in one spot (Ex: between a cage and roller). The debris will wear off a very small portion of the roller's surface. Typically, these are seen more on bearings with coating, as the coatings can wear off more easily than the actual surface of the roller. Most of these lines have little or no depth to them, as they are polished surfaces. As with false Brinell marks, if these lines do not form pitting, the bearing is fine for continued operation.

Figure 18: Bearing roller with typical radial running lines

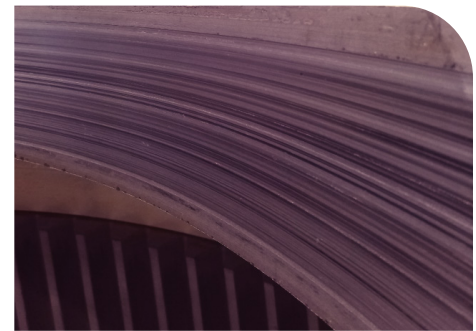
Often bearing outer races spin inside their respective bore due to lack of fit, over torquing, or other circumstances. A spinning outer race inside a bore will generate debris, which will cause the bore to grow larger, compounding the problem. If left unchecked, even minor bore spin can cause the bore to become oversized. As a result, the bearings become out of concentricity with their axial partners, causing edge loading, as well as misaligned gear meshes. Up-tower and down-tower pinning solutions are being developed for positions that have a high tendency to spin. When Down-tower the bore can be repair via sleeving, metal spraying, or oversizing the bore for a larger bearing.

Figure 19: Bearing bore with severe spin damage

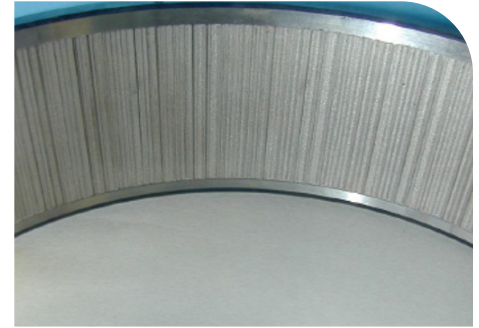
Electrical fluting occurs when a current is passed through the bearing. The current causes localized material to heat up (like micro-welding) and break off, creating frosted areas that look like micro pitting. Electrical fluting is not a common failure mode in wind turbine gearboxes but can be seen if an electrical component (such as the generator) is not grounded properly. If fluting is found, the bearing must be replaced as soon as possible, as the damage will only progress.

Figure 20: Bearing race with electrical fluting damage

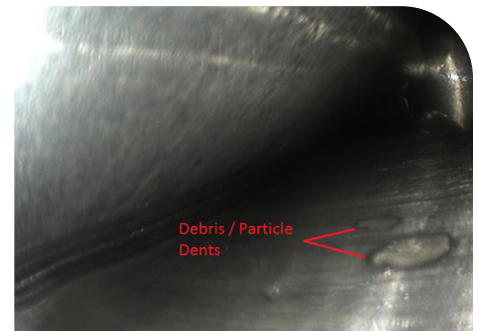
Denting formed when harder foreign particles come into contact with roller and raceway. These are smaller particles and while the indentations are created, they may not progress if the debris is not constant and flushed after a cycle or two. Denting is usually not progressive, so long as it does not form pits. If you see dents that are progressing after a few inspections, but no pitting has formed, it typically means that there is a different component in the gearbox that is failing and shedding debris, causing denting in other areas of the gearbox. In any case, if you see pitting that is progressive, the bearing should eventually be replaced, and the rest of the gearbox should be inspected thoroughly to find the source of the debris.

Figure 21: Bearing race with a typical debris / particle dent

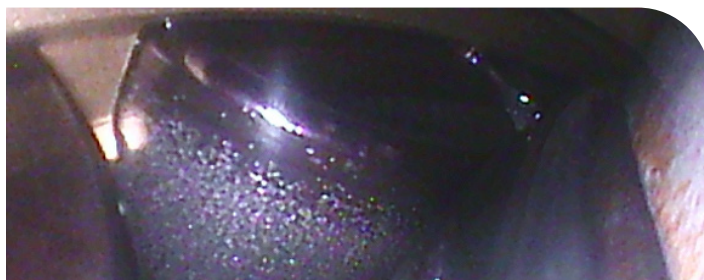
Micro pitting can be found on races and/or rollers. Micro pitting can be operated in some cases but may lead to higher operating temperatures depending on severity. It can also develop into macro pitting. In any case, if micro pitting is found, it needs to be periodically checked for progression.

Figure 22: Bearing roller that was found to have micro pitting

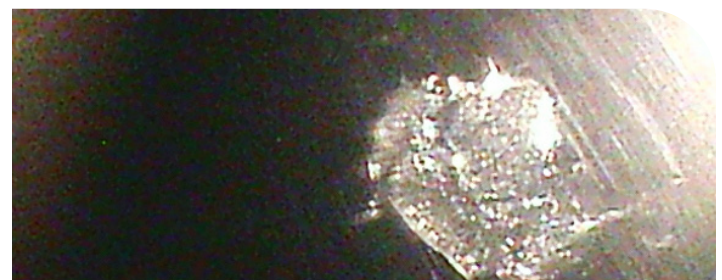
While micro pitting is typically found on races and/or rollers, macro pitting is typically found on the inner race of a bearing (as that is very commonly the most stressed component of the bearing), but still can be found on the rollers and outer race in some cases. If macro pits are small enough and in small quantity, they can be ok to run with periodic inspections to assess progression. Once macro pitting is determined to be progressive, the bearing will eventually need to be replaced.

Figure 23: Bearing race with macro pitting

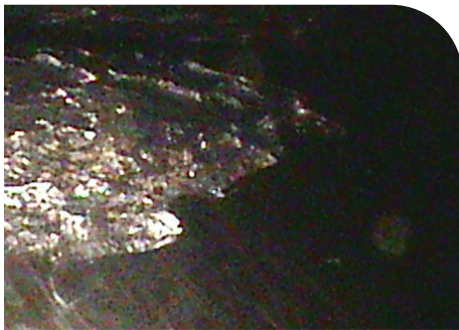
Spalling in bearings can be initiated by both surface and subsurface defects. Spalling in bearings, like in gearing, can be the result of the coalition of macro pits. This failure mode can have various shapes and depth, but in every case, once a bearing has spalled the failure mode will progress. A replacement plan for the damaged bearing should be put in place and prioritized based on the level of progression.

Figure 24: Bearing race with severe spalling

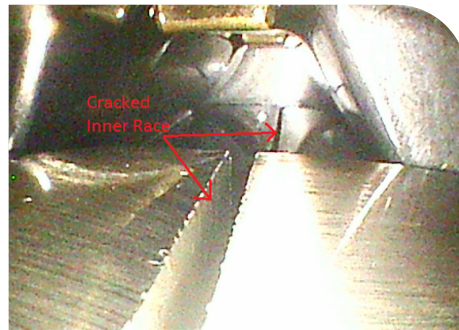
Figure 25: Bearing inner race with a pronounced axial crack

Cracks in bearings usually appear axial in nature. Some are more obvious as shown in Figure 25, while others are more difficult to spot as in Figure 26. They are often caused by white etch areas found in the microstructure of the bearing that can form over time. There are many contributing factors to the initiation and progression of white etch cracking (WEC), such as oil film thickness, oil composition, hoop stress, fatigue stress, and others. Once a bearing has cracked, the crack will cause a stress riser, and eventually lead to pitting and very quickly turn to spalling. A bearing with a through crack will also lose its fit to the shaft, which may initiate other failure modes within the gearbox. A bearing that is found to have a crack should be replaced as quickly as possible.

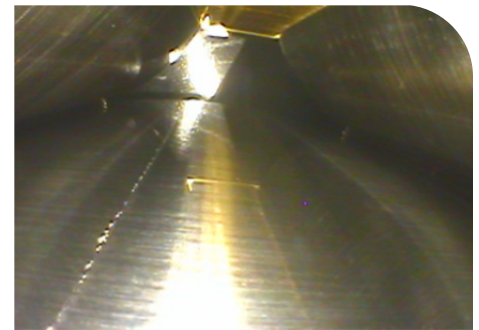
Figure 26: Bearing inner race with a subtle axial crack

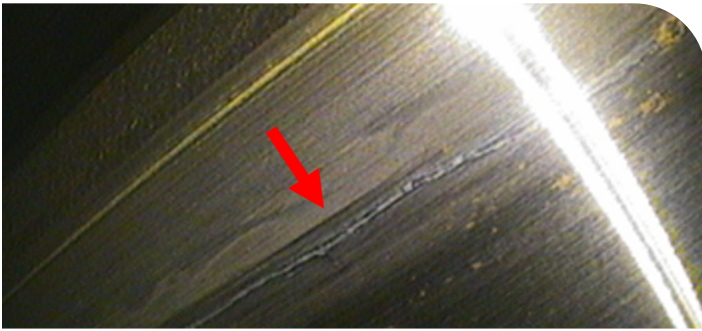
Figure 30: Scratch on gear tooth

The image on the below left (Figure 30) shows a scratch on the gear tooth. The image on the below right (Figure 31) demonstrates the shiny result of micro pitting along a grinding asperity. Both were mis-diagnosed as gear tooth cracks.

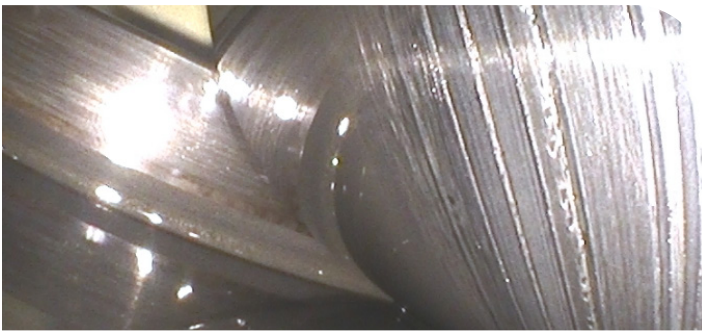
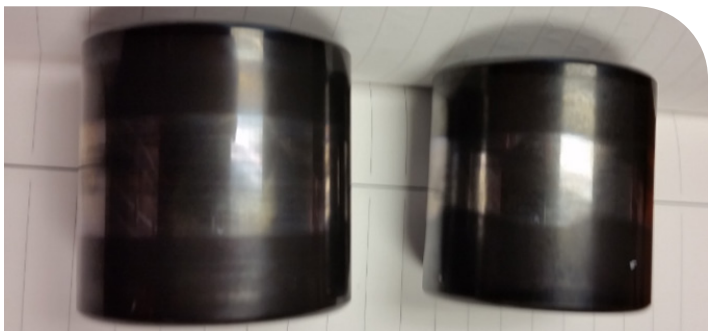
The image below left (Figure 32) is a common bearing with a black oxide coating (conversion). The shiny track in the center of the roller (foreground) is sometimes misdiagnosed as micro pitting or debris tracks. When viewed with the unaided eye under normal lighting (below right), it is evident that the black oxide had worn away in the loaded zone, but there is nothing as severe as damage.

Figure 32: Black Oxide Coating worn away, depicted via bore scope on the left, and unaided visual on the right

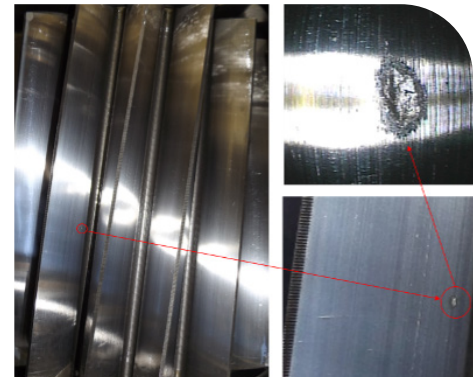
In some cases, early signs of problems can be almost invisible to the less experienced inspector. The below image (Figure 33) of pinion gear teeth looks very clean with almost no signs of wear. Upon close inspection significant but tiny macro pits have developed in the dedendum of the gear teeth. This should be flagged and monitored for progression.

Figure 33: Small macro pit as seen by normal visual, and through a bore scope
