RP 301

Recommend Practices for Wind Turbine Blades

AMERICAN
CLEAN
POWER

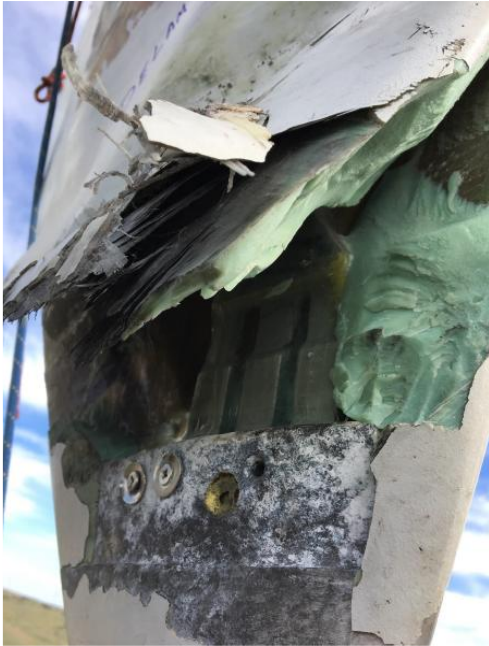
Figure 8: Examples of Damage Due to Lightning Strikes

(a) Significant Delamination

(b) Trailing Edge Blowout

Lightning strike damage is commonly found in the outboard portion of the blade, at or near the tip of the blade. It is important to note that the extent of the external damage to the blade does not necessarily reflect the internal condition of the blade. Following a suspected lightning event, the blades should be inspected for evidence of a lightning strike, including, but not limited to, laminate damage, bond damage, or damage to the LPS (Figure 8a). Laminate damage can be indicated by burnt or missing paint; charring near LPS receptors, at the blade tip, or main spar; or regions of frayed laminate or delamination. Bond damage can be indicated by a split in the trailing edge or an open tip (Figure 8b). The LPS should also be inspected for damage. A compromised LPS can be indicated by missing hardware, such as lightning receptors; disconnected, severed, or frayed LPS cable at the blade root; or heavy scorching to the various components of the LPS.¹⁶

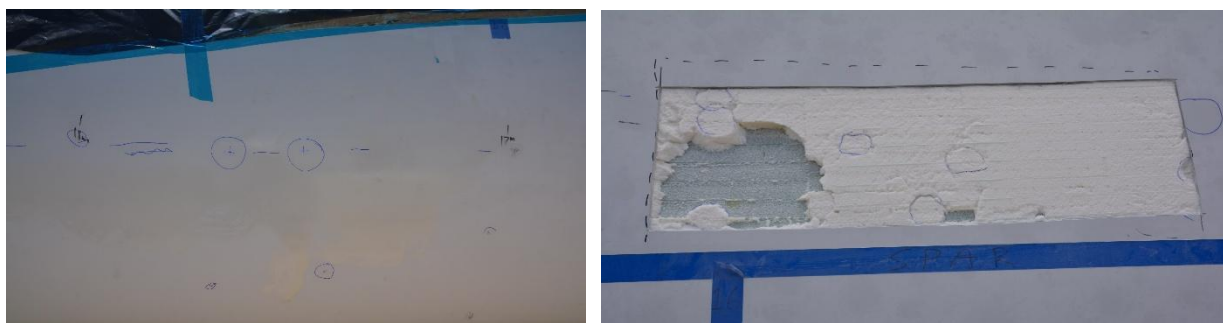
Figure 10: Example of Damage Due to Impacts from Large Hail

Ice events include hailstorms with hail of a notable size (e.g., larger than 25 mm or 1 in.) and major ice storms during which significant accretion of ice on the blades was observed or suspected and during which it was also observed or suspected that such ice may have fallen from the blades striking other blades. Following an ice event, blades should be inspected if they are known or suspected to be susceptible to damage from impact by ice. Blades with shells utilizing very thin composite facesheets (e.g., blades utilizing central spar structures and lightly structural shells) are particularly susceptible to such damage. Damage can often consist of delamination of facesheets from core with minimal visible damage on the exterior surface. Visual inspections should employ binoculars or a drone and, if needed, a nondestructive examination. Figure 10 illustrates an example of the visible indications following damage due to large hail as well as the internal damage that was revealed by a destructive inspection performed as part of the blade repair.

(a) Small Exterior Indications (b) Internal Damage Revealed by Destructive Inspection

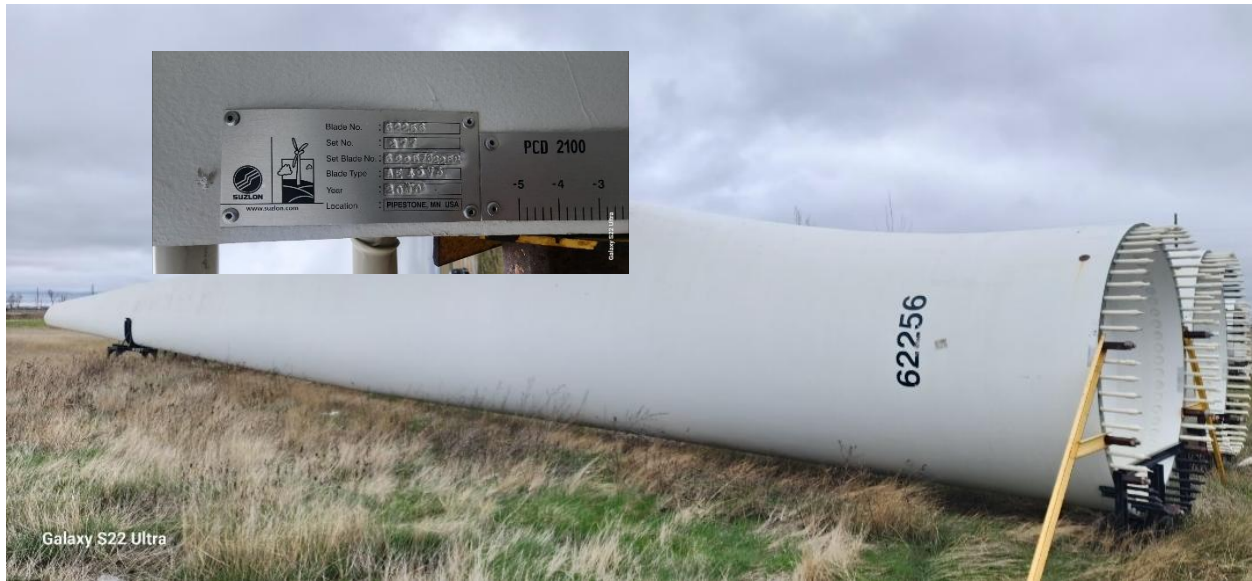
Figure 11: Example of Blade Serial Number Marking and Nameplate

Figure 11 shows examples of acceptable photos.

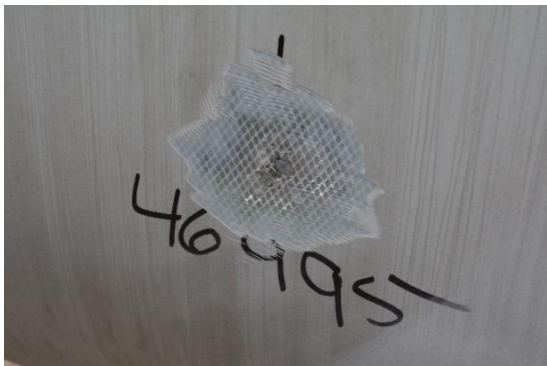
Figure 13: First Illustration of Layer-by-Layer Removal of Damage Due to a Lightning Strike

(a) Removal of Top Coat

(b) Removal of Some Glass Layers

(c) Removal of Outer Glass Skin

Figures 13-16 show examples of acceptable photos.

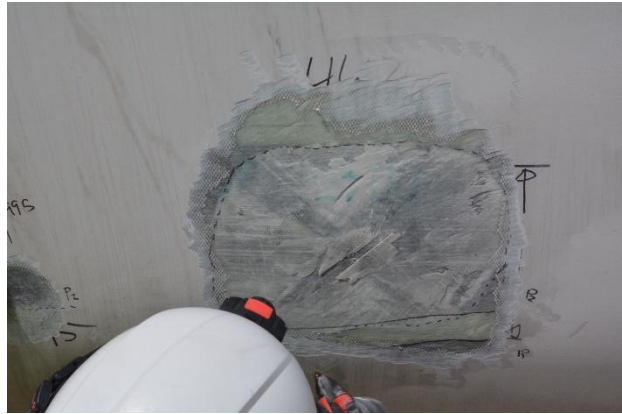
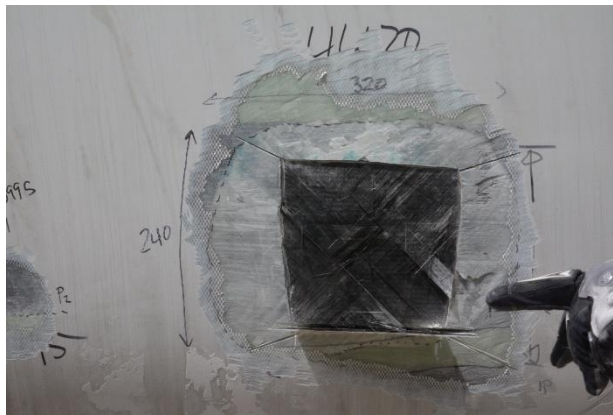
Figure 14: Second Illustration of Layer-by-Layer Removal of Damage Due to a Lightning Strike

(a) Removal of Top Coat

(b) Removal of Some Glass Layers

(c) Removal of Outer Glass Skin

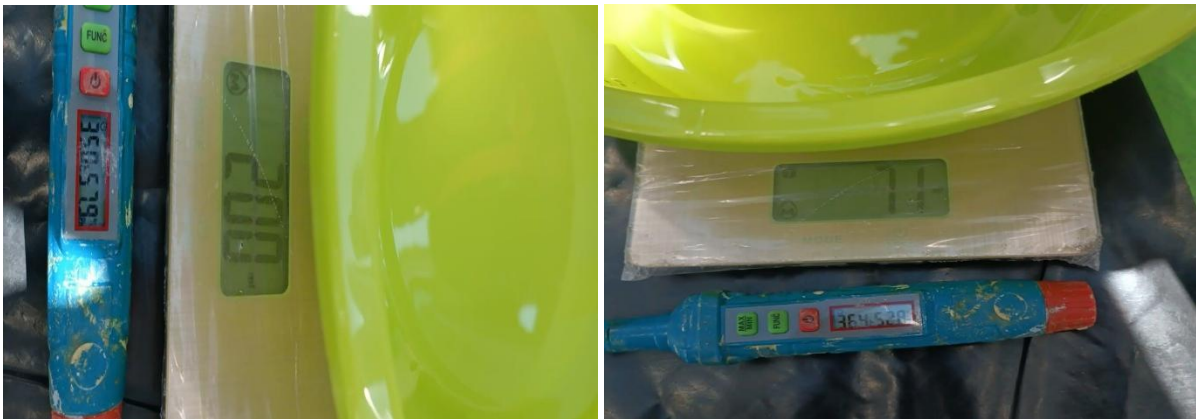
Figure 21: Documentation of Weighing Out the Resin and Hardener

- Once resin amount is estimated, the correct hardener to resin mixture should be weighed out in separate containers (Figure 21).
- If vacuum consolidation is to be used, all consumable materials, such as release film, breather, vacuum bag, and tacky tape, should be cut ahead of the start of the layup. The vacuum pump and all hoses and gaskets should be inspected and ready for use. Tacky tape should be placed on the surface of the blade, with the exposed side protected, before the start of the layup so that materials can be quickly applied after the layup is complete.

Figures 20-23 show examples of acceptable photos.

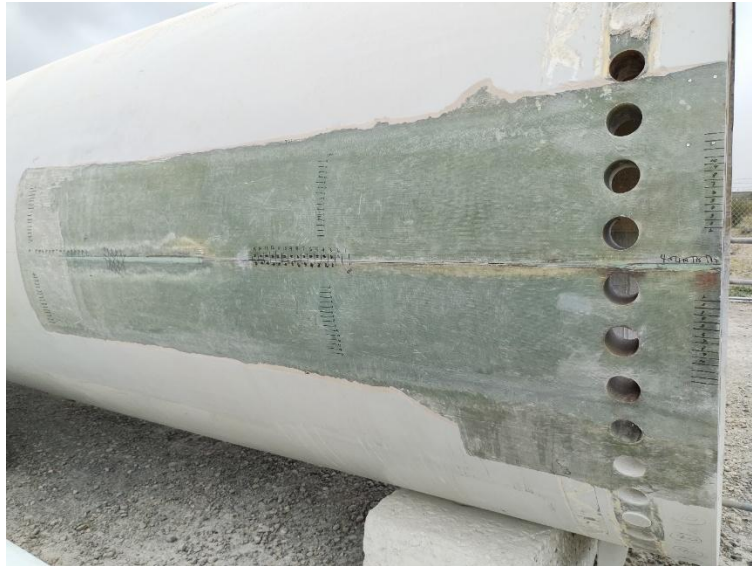
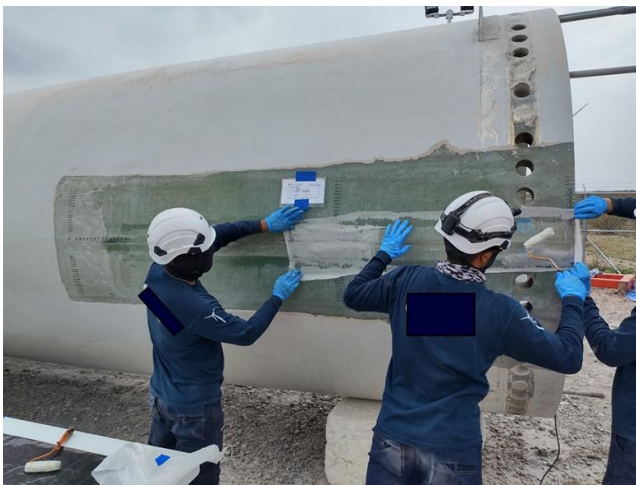
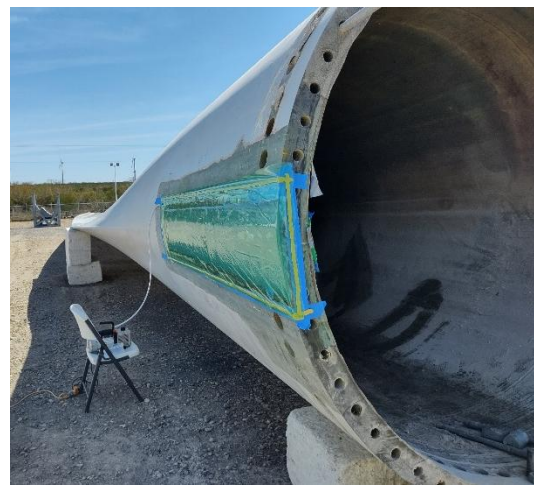
Figure 22: Example of Lamination During a Blade Repair

- Once resin is mixed, the first layer closest to the inner surface should be wet out with an appropriate amount of resin. A roller and/or squeegee should be used to ensure that the resin is thoroughly introduced and wet out in the glass layer. (Figure 22)

(a) Marking the Lamination Schedule

(b) Applying the First Layer of Laminate

(c) Finished and Bagged First Sequence

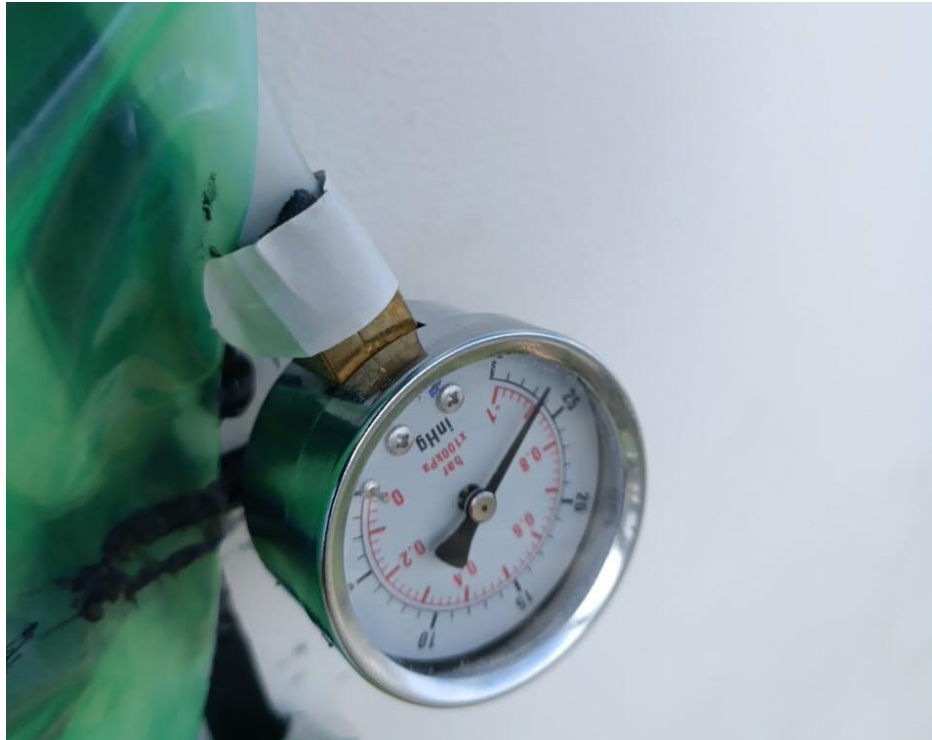
Figure 23: Documentation of the Vacuum Level

- Peel ply layer should be placed on top of the last layer.
- Once all materials are placed, if vacuum consolidation is to be used, the vacuum bagging materials can be added to the surface. Release film should go directly on top of the wet layers, then a breather layer to allow airflow, gasket placed out of the way of the repair layers, and finally the vacuum bag. (Figure 23)

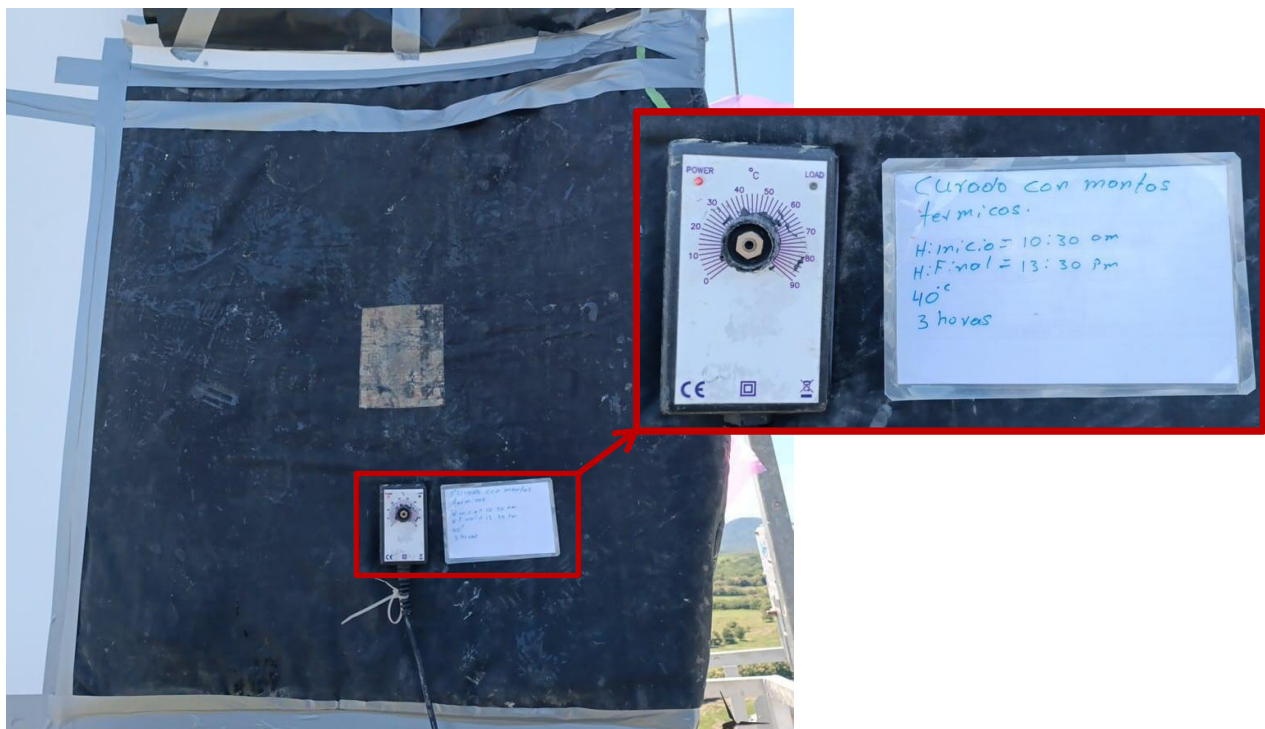
Figure 24: Illustration of the Recording of the Cure Temperature and Time

- Cure time and temperature is within specifications of resin and/or process requirements of OEM.

Figure 24 shows an example of an acceptable photo.

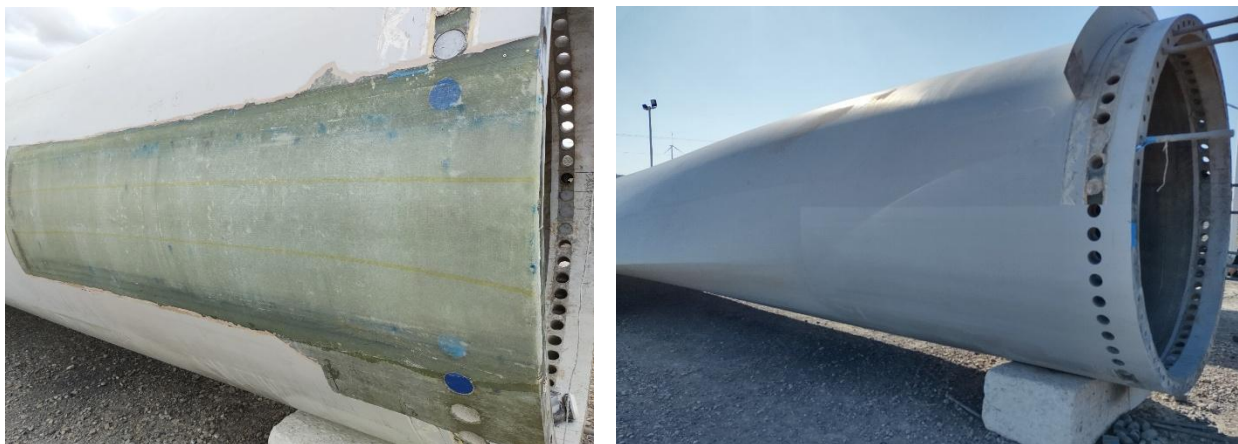
Figure 26: Example of the Finishing of a Blade Repair

(a) Sanding of the Finished & Cured Laminate (b) After Paint and Drilling of Barrel Nut Holes

Figures 25 and 26 show examples of acceptable photos.
