RP 301

Recommended Practices for Wind Turbine Blades

AMERICAN
CLEAN
POWER

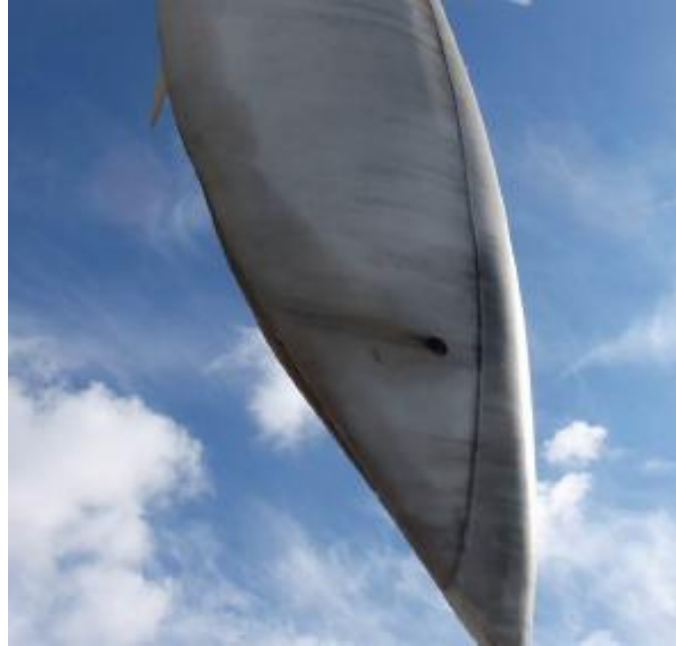
(a) Significant Delamination

(b) Trailing Edge Blowout

Figure 8: Examples of Damage Due to Lightning Strikes

Lightning strike damage is commonly found in the outboard portion of the blade, at or near the tip of the blade. It is important to note that the extent of the external damage to the blade does not necessarily reflect the internal condition of the blade. Following a suspected lightning event, the blades should be inspected for evidence of a lightning strike, including, but not limited to, laminate damage, bond damage, or damage to the LPS (Figure 8a). Laminate damage can be indicated by burnt or missing paint; charring near LPS receptors, at the blade tip, or main spar; or regions of frayed laminate or delamination. Bond damage can be indicated by a split in the trailing edge or an open tip (Figure 8b). The LPS should also be inspected for damage. A compromised LPS can be indicated by missing hardware, such as lightning receptors; disconnected, severed, or frayed LPS cable at the blade root; or heavy scorching to the various components of the LPS.¹⁶

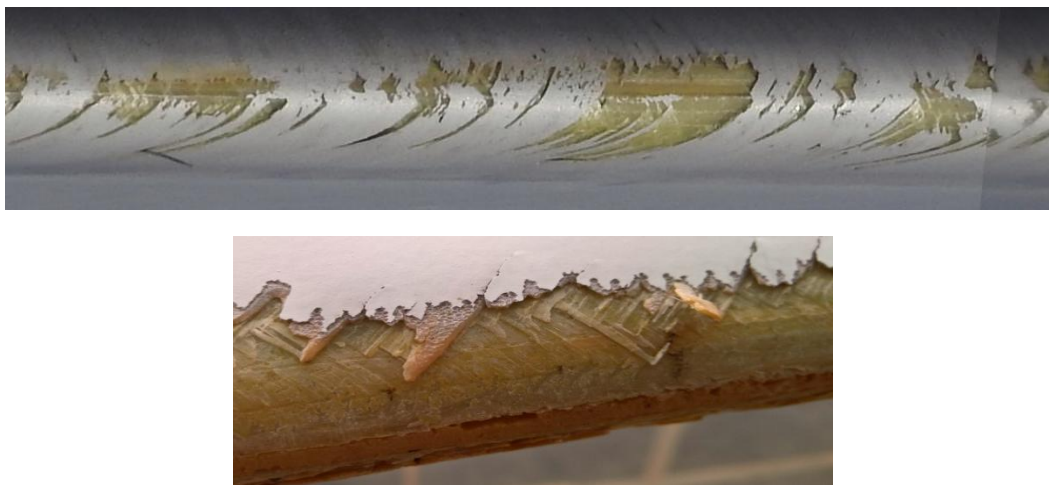
Figure 9: Examples of Severe (Category 5) Leading Edge Erosion

Other environmental conditions that should be considered when planning blade inspection type in frequency are rain, hail, and dust storms. Locations that experience increased rainy or dusty conditions may be more susceptible to leading edge erosion. Leading edge erosion is a damage mode wherein the surface of a blade experiences gradual material loss over time due to the impact of hydrometeors, such as rain droplets and hail, or atmospheric particles, such as dust (Figure 9). This loss of surface material leads to increased surface roughness, which has been shown to have a significant effect on the wind turbine’s annual energy production.²¹ Sites that are deemed to experience increased frequencies of rainstorms, hailstorms, or dust storms should pay special attention to the leading edge surface of their blades during external visual inspections.

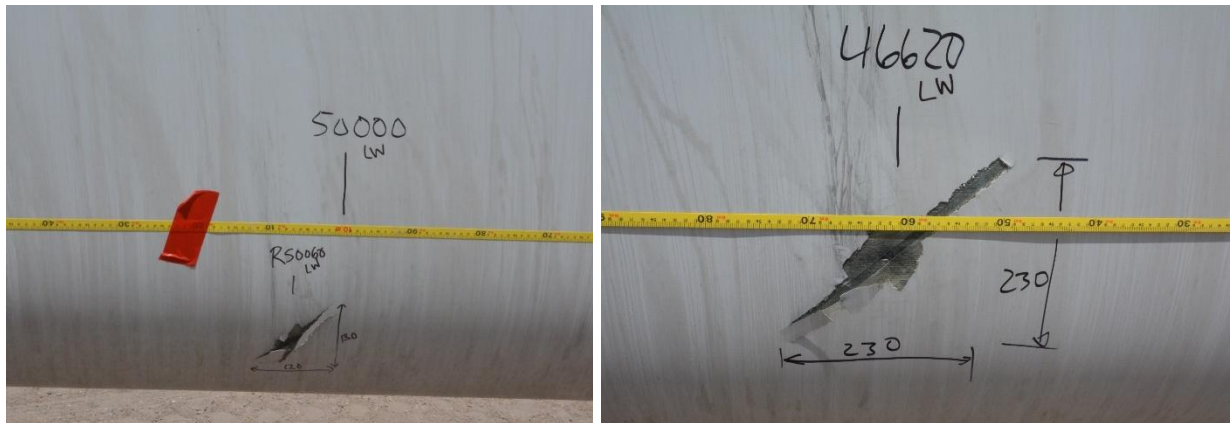
Figure 12: Examples of Lightning Strike Damage Annotated During Initial Inspection

Figure shows examples of acceptable photos of lightning strike damage annotated during an initial inspection.

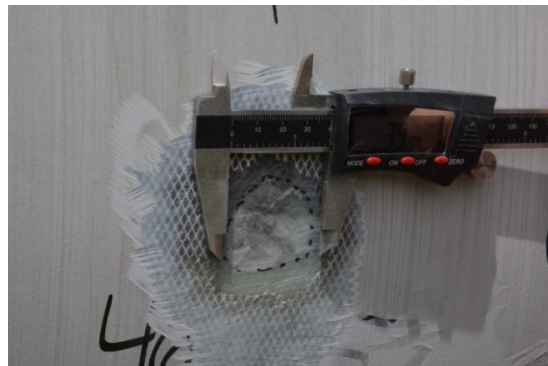
(a) Removal of Top Coat

(b) Removal of Some Glass Layers

(c) Removal of Outer Glass Skin

Figure 13: First Illustration of Layer-by-Layer Removal of Damage Due to a Lightning Strike

Figures 13-16 show examples of acceptable photos.

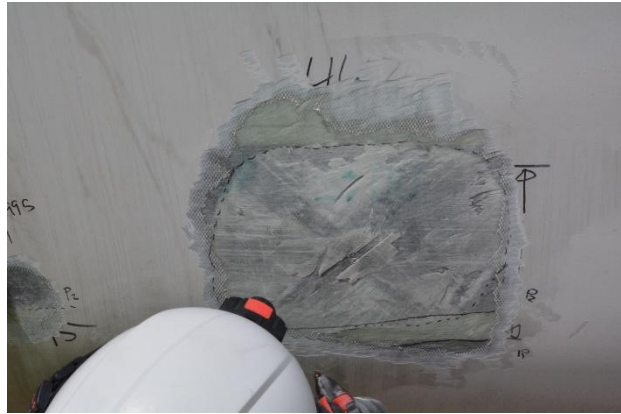
(a) Removal of Top Coat

(b) Removal of Some Glass Layers

(c) Removal of Outer Glass Skin

Figure 14: Second Illustration of Layer-by-Layer Removal of Damage Due to a Lightning Strike

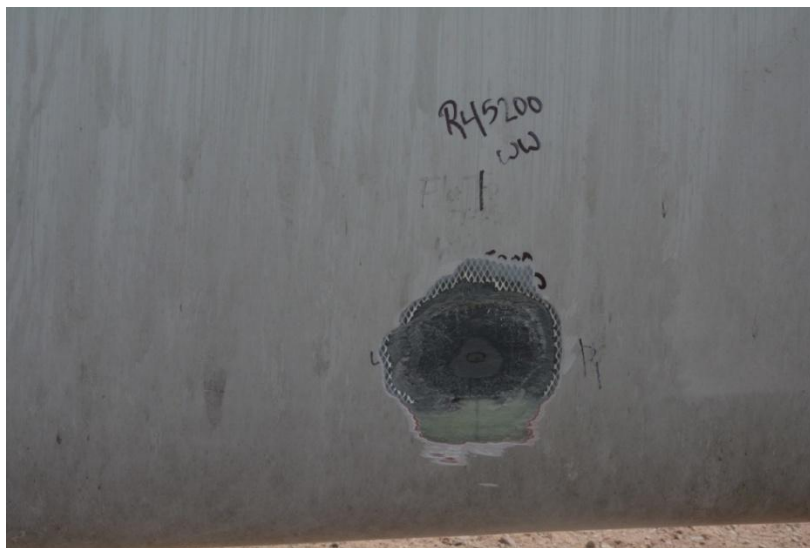
Figure 15: Illustration of a Grind to the Bottom of a Lightning Damage to a Carbon Spar Cap

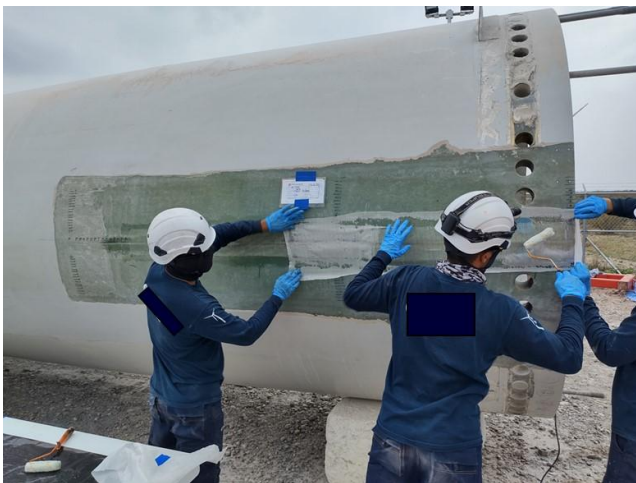
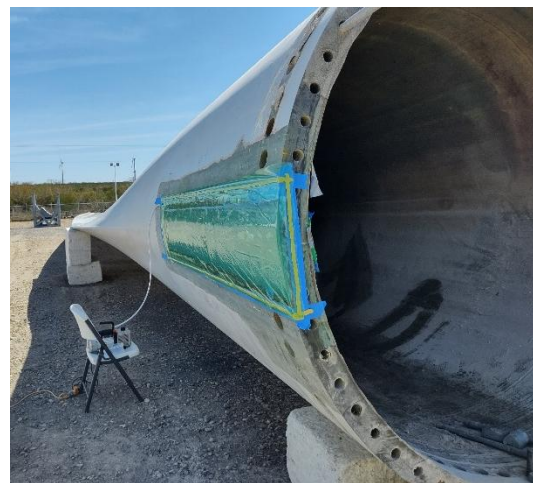
(a) Marking the Lamination Schedule

(b) Applying the First Layer of Laminate

(c) Finished and Bagged First Sequence

Figure 22: Example of Lamination During a Blade Repair

- Once resin is mixed, the first layer closest to the inner surface should be wet out with an appropriate amount of resin. A roller and/or squeegee should be used to ensure that the resin is thoroughly introduced and wet out in the glass layer. (Figure 22)

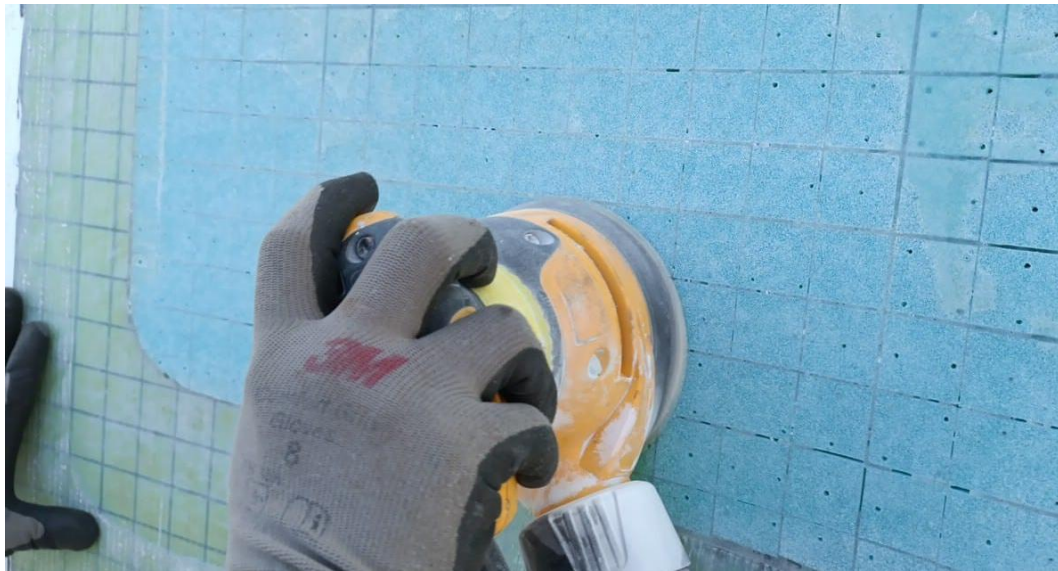
Figure 25: Example of the Final Sanding of a Glass Repair over Foam Core

Figures 25 and 26 show examples of acceptable photos.

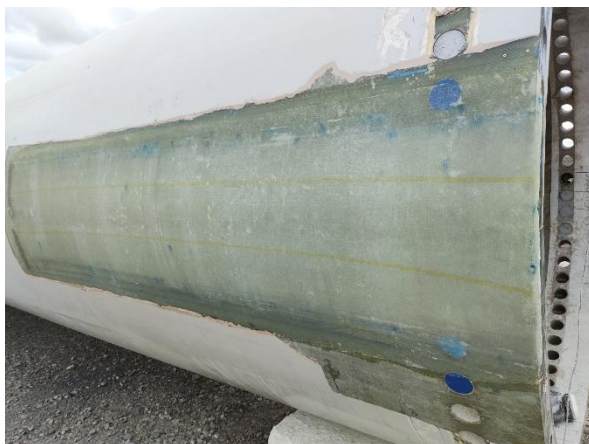
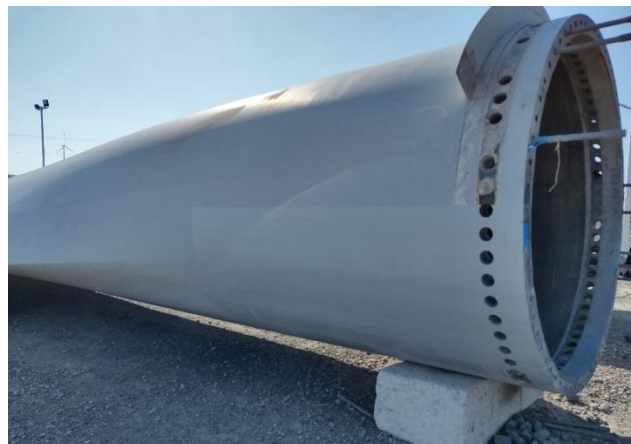
(a) Sanding of the Finished & Cured Laminate

(b) After Paint and Drilling of Barrel Nut Holes
